PRO-CERTIFIED HOME INSPECTION, PLLC

## RESIDENTIAL INSPECTION

216 Flying Tigers Trl  
Jarrell, TX 76537

# PROPERTY INSPECTION REPORT FORM

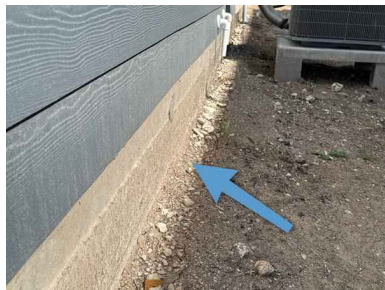
**1: Soil Erosion From Roof Runoff**

Soil erosion was observed around the home from roof runoff. Long-term soil erosion near the foundation can cause settlement and or movement of the foundation. Gutters can help divert water away from the foundation and help mitigate settlement.

Recommendation: Contact a qualified professional.

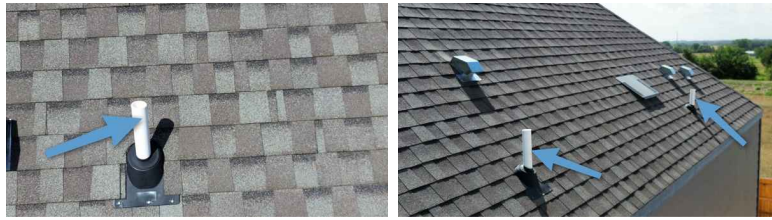
**1: Pipes Missing Paint**

One or more sewer vent pipes were observed to be missing paint on the roof. PVC and neoprene will deteriorate where exposed to ultraviolet rays. Painting the vent pipe can help prevent deterioration caused by exposure to ultraviolet rays.

Recommendation: Contact a qualified professional.

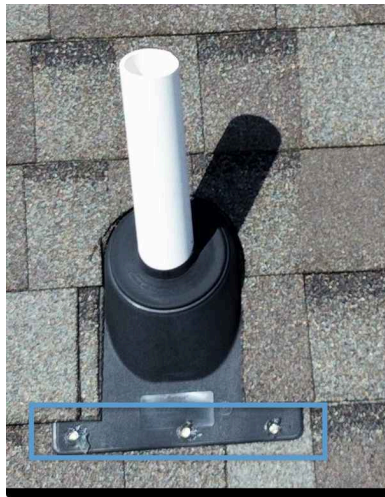
## 2: Flashing Fastner missing sealant

Observed one or more flashing fasteners that were missing sealant. This could cause a leak in the roof. Recommend sealing all flashing fasteners.

Recommendation: Contact a qualified professional.

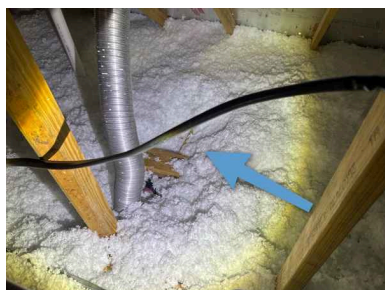
## 1: Disturbed Insulation

Insulation appears to have been pulled out and/or disturbed. Recommend a qualified insulation contractor evaluate and repair.

Recommendation: Contact a qualified insulation contractor.

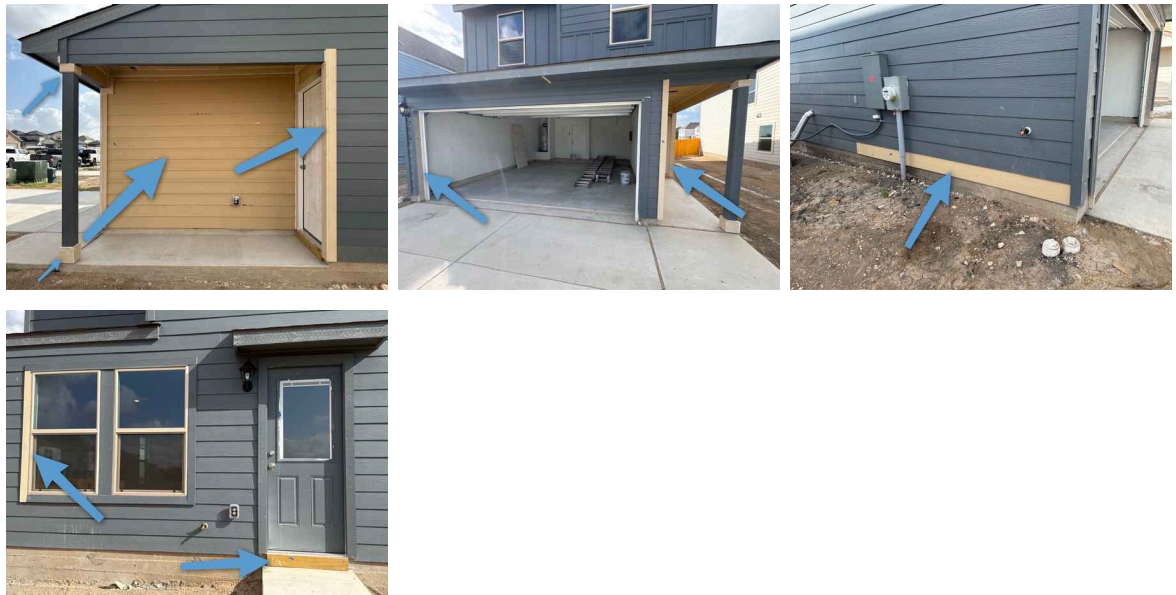
**1: Missing Paint**

One or more areas were missing paint at the time of the inspection. Recommend paint completion.

Recommendation: Contact a qualified professional.

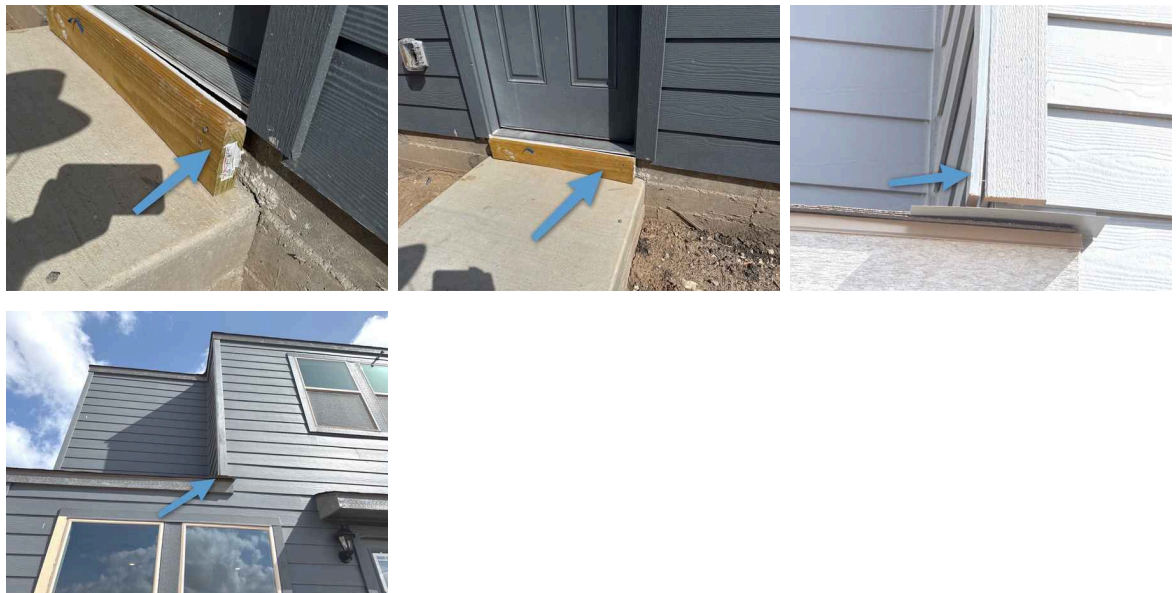
## 2: Loose / Missing Trim

Trim pieces were observed to be loose at one or more locations. Recommend securing the trim in these areas.

Recommendation: Contact a qualified professional.

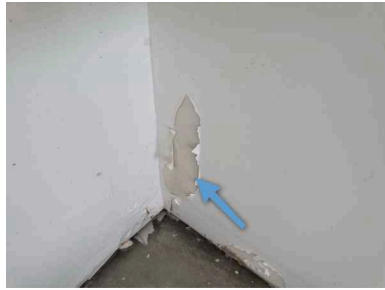
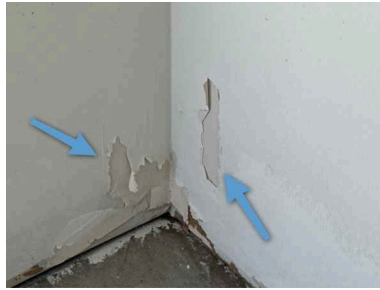
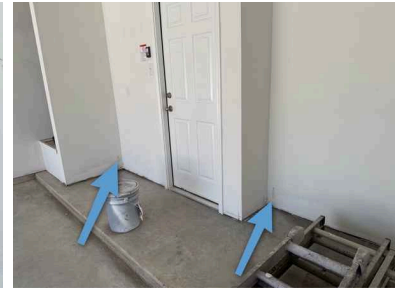
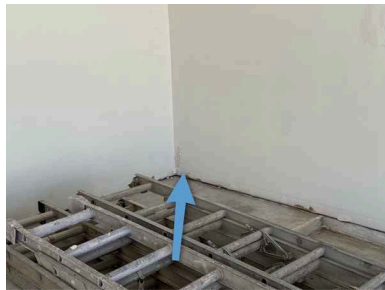
## 3: Peeling Paint

Paint was observed to be peeling at one or more locations. The missing paint can lead to moisture damage of the building materials. Repair as necessary.

Recommendation: Contact a qualified professional.

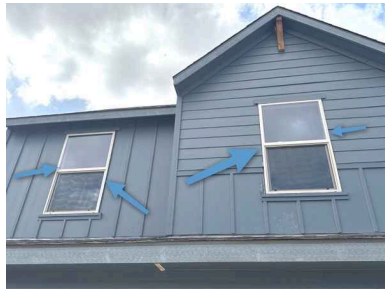
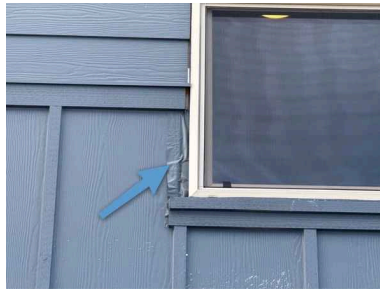
#### 4: Missing Trim

One or more areas is missing trim. Install as necessary.

Recommendation: Contact a qualified professional.

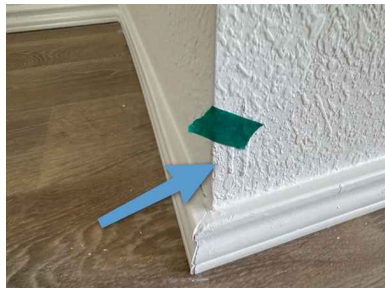
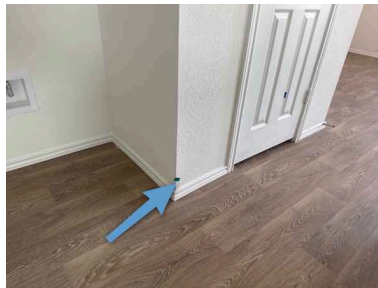
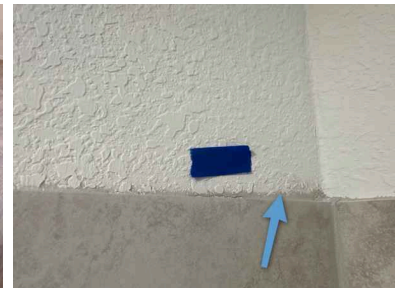
Master Bathroom

#### 5: Wall- Texture Inconsistencies

Observed one or more areas with texture inconsistencies. Photos are a sampling. Repair as needed to improve appearance.

Recommendation: Contact a qualified professional.

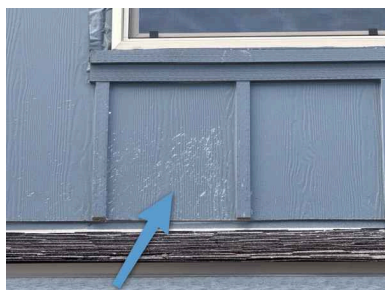
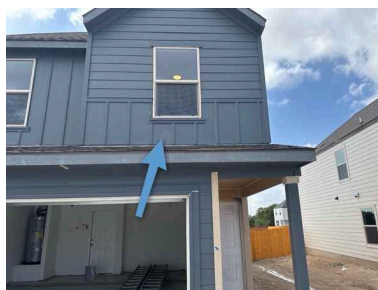
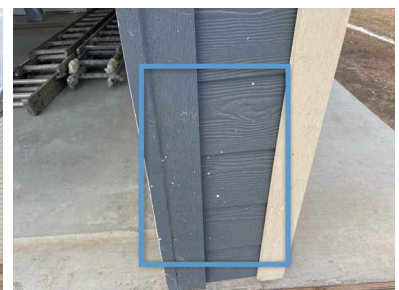
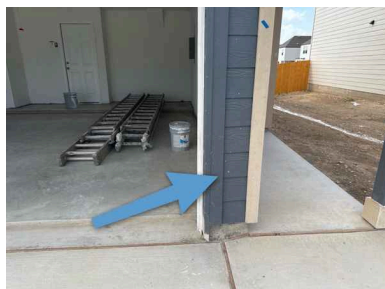
Observed one or more areas that were in need of a paint touchup. There were multiple areas that needed touching up. Photos are a sampling.

Recommendation: Contact a qualified professional.

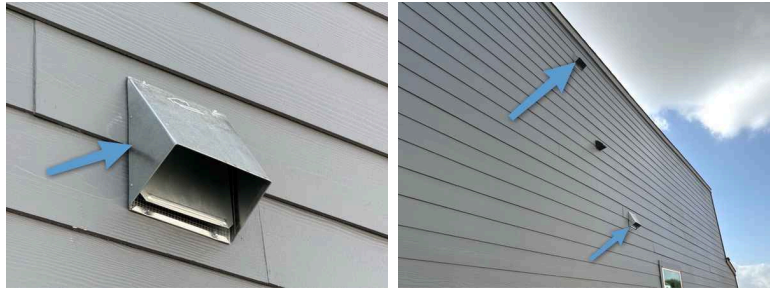
## 7: Missing Caulk / Paint at Wall Vent Cover

Observed one or more areas that were missing caulk and or paint at the vent cover. Recommend caulking and painting cover.

Recommendation: Contact a qualified professional.

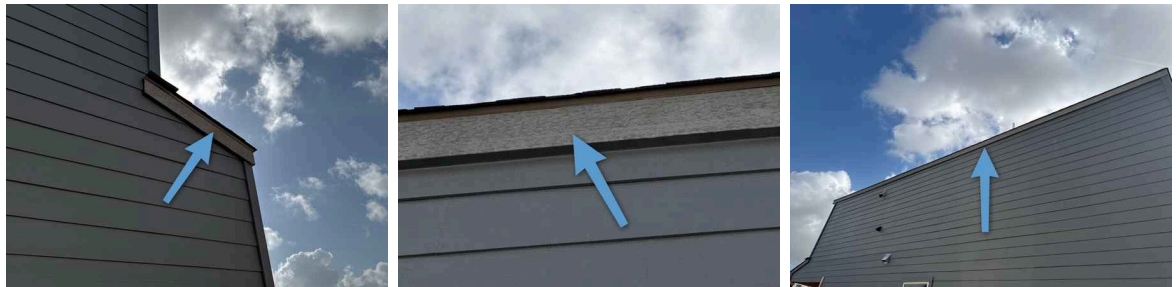
### 8: Missing Second Coat of Paint on Trim

Trim surfaces lack a second coat of paint, leaving the finish incomplete. This exposes the primer or base coat and compromises the protective finish. The trim should receive a second coat of paint to ensure proper coverage, durability, and aesthetic consistency.

Recommendation: Contact a qualified professional.

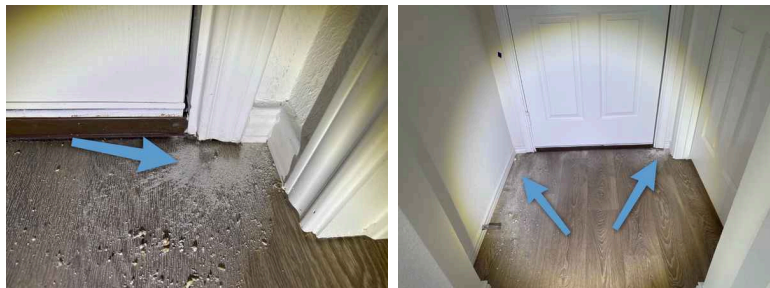
**1: Paint/debris on Floor**

Observed paint stains and/or constructed debris on the floor and one more areas. Recommend cleaning prior to closing.

Recommendation: Contact a qualified professional.

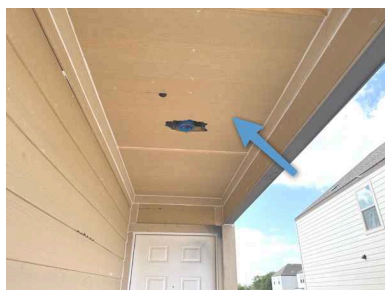
**2: Ceiling Missing Paint**

One or more areas of the ceiling missing paint and or caulk and are in need of a paint touch up. Recommend repair.

Recommendation: Contact a qualified professional.

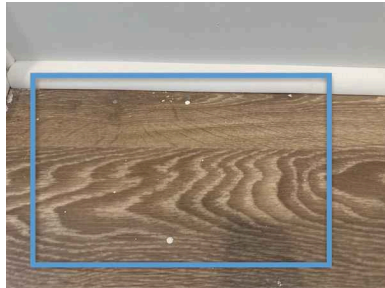
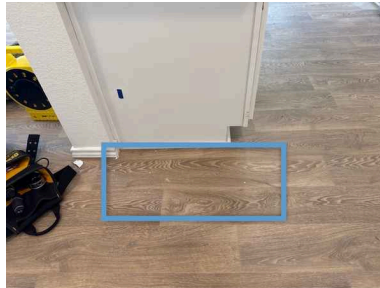
Kitchen

Observed one or more areas of globs of dried paint on one or more floors. Recommend repair.

Recommendation: Contact a qualified professional.

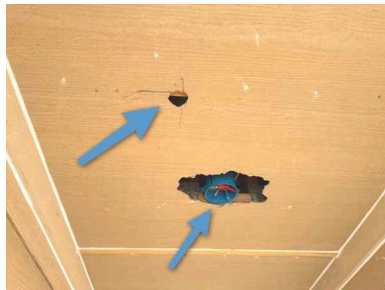
Front porch

**4: Damaged Ceiling- exterior**[🔧 Maintenance Item](#)

An oversized, irregular opening and damaged soffit paneling were observed at ceiling. Unsealed openings in exterior ceilings leave structural framing and trim exposed to pest intrusion, moisture entry, and accelerated material deterioration. The ceiling paneling should be properly repaired or replaced and sealed by a qualified contractor to ensure a complete exterior building envelope.

Recommendation: Contact a qualified professional.

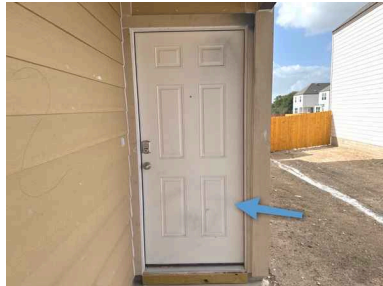
Front door

**2: Stain/ Paint/Refinish Needed**

Door finish is worn. Recommend refinish and/or paint to maximize service life.

Recommendation: Recommended DIY Project

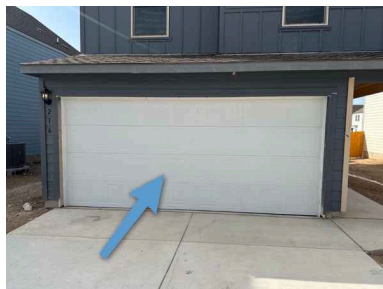
Not painted at time of inspection. Paint as desired.

Recommendation: Contact a qualified professional.

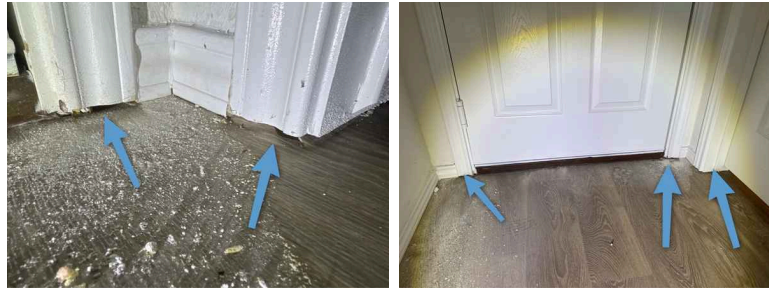
**4: Caulk Door Trim**

Missing caulk at the door trim. Recommend repair.

Recommendation: Contact a qualified professional.

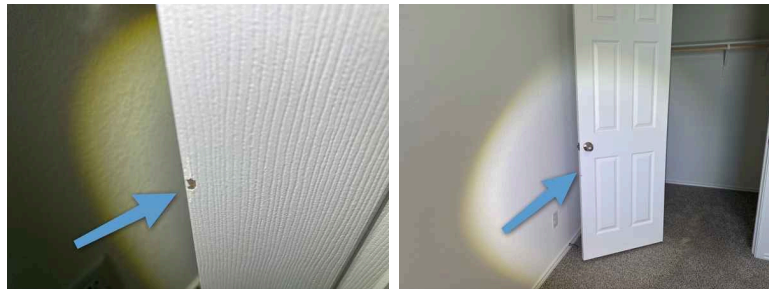
## 5: Blemish/Chipped/Scratch

Minor door blemish/scratch. Touch up as desired.

Recommendation: Contact a qualified professional.

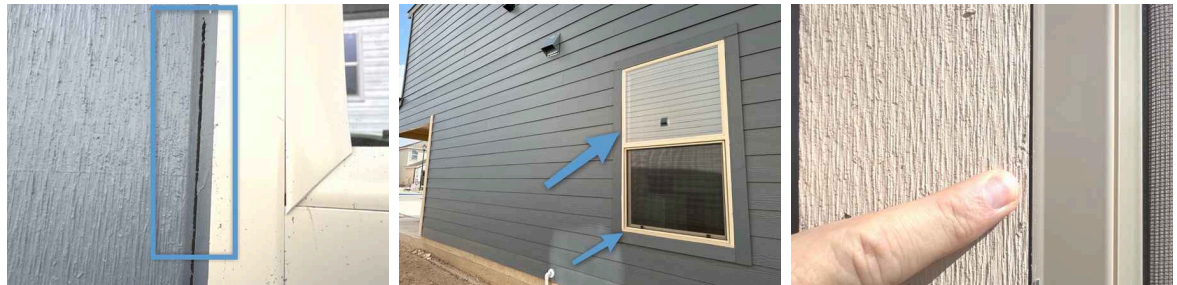
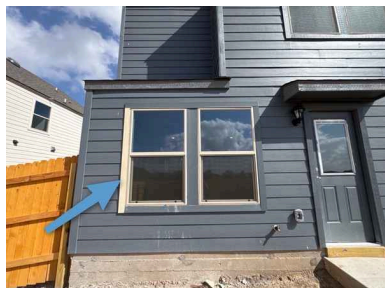
### 1: Window Caulk Missing/Deteriorated

One or more windows were observed to have missing and/or deteriorated caulk. Recommend sealing these areas to avoid water intrusion. This will be ongoing maintenance.

Recommendation: Contact a qualified professional.

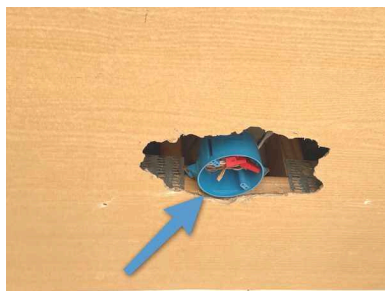
Front porch

### 1: Light Fixture Missing

Light Fixture missing in one or more areas. Install as needed.

Recommendation: Contact a qualified professional.

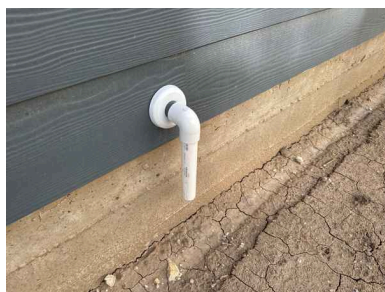
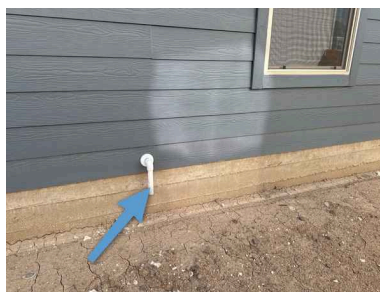
To protect from UV damage.

Recommendation: Contact a handyman or DIY project

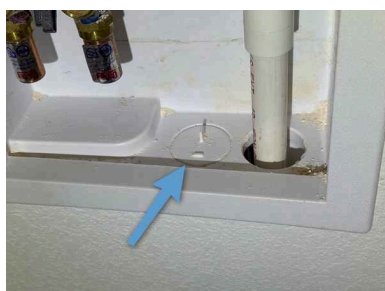
Laundry room

### 2: Remove Washing machine drain cap

The plastic knockout plug or test cap remains in place at the washing machine drain box in one or more locations. This obstruction prevents the discharge of wastewater, which will cause a backup during the appliance's initial use; I recommend having the builder or a licensed plumber remove the cap to ensure the drain is functional and ready for service.

Recommendation: Contact a qualified professional.

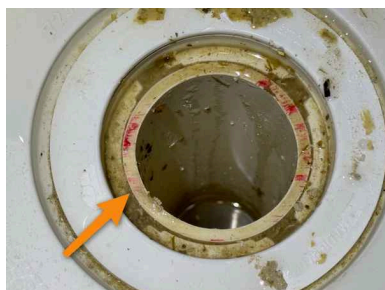
### Master Bathroom

The shower drain assembly lacks a watertight seal between the inner PVC drain pipe and the outer drain body fitting, allowing standing water and debris to collect within the open annular gap. Over time, water can seep past this unsealed joint and leak beneath the shower base, potentially causing concealed water damage to the subfloor or building materials below, as well as fostering foul odors and bacterial growth. A licensed plumber should evaluate the drain connection and install the proper compression gasket or seal to restore a watertight waste fitting.

Recommendation: Contact a qualified professional.
