PRO-CERTIFIED HOME INSPECTION, PLLC

## RESIDENTIAL INSPECTION

2705 Wolkin Cove  
Round Rock, TX 78681

# PROPERTY INSPECTION REPORT FORM

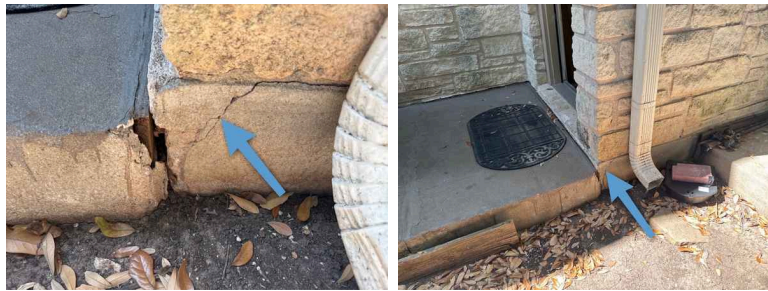
### 1: Corner Pop

Foundation corner fracture(s) were observed, which are generally the result of differential movement between the masonry walls and the concrete foundation. Although this condition did not appear to adversely affect the structure, sealing these cracks may be desired. Repairs would be for cosmetic purpose at this point. Please note that the corners should be examined periodically. If the fracturing worsens and the corner(s) break off then the brick veneer may lack proper support and repair would be needed.

Recommendation: Contact a qualified concrete contractor.

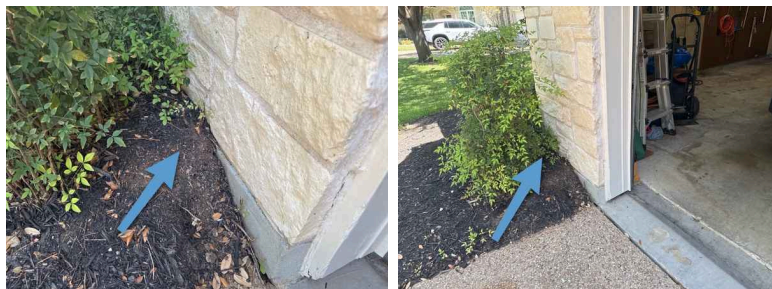
## 2: High Soil Line

The soil is higher than the foundation at one or more locations. This can allow moisture to penetrate the wall into the home. This could lead to wood rot and or possible fungal growth in the wall cavity and possibly create a conducive condition for wood destroying insects such as termites. It is recommended to have a minimum of 4 inches of the foundation exposed.

Recommendation: Contact a qualified professional.

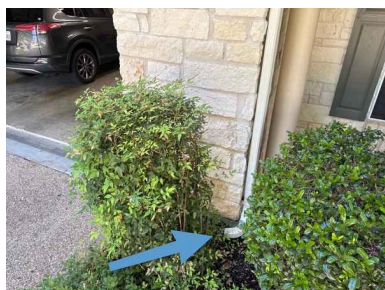
## 3: Splash blocks missing

Recommend adding splash blocks where missing to prevent soil erosion.

Recommendation: Contact a handyman or DIY project

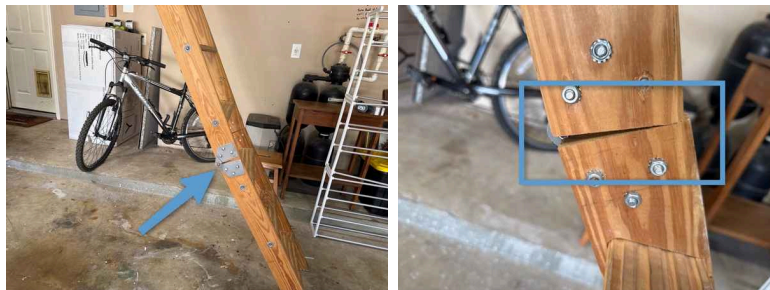
### 5: Attic Ladder Improperly Cut

The attic ladder is not cut properly. The legs of the ladder should be cut to set flush to the floor. Adjust as necessary.

Recommendation: Contact a qualified carpenter.

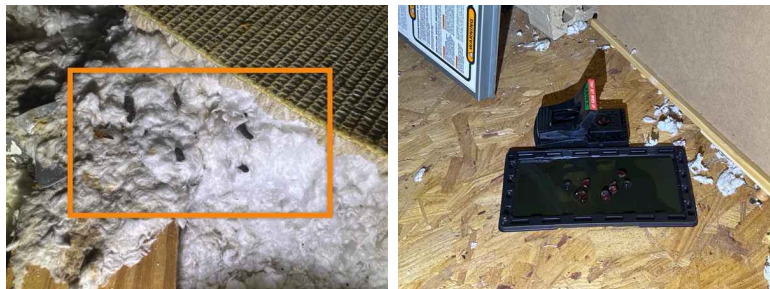
### 6: Evidence of Rodent Activity

Evidence of Rodent Activity was observed in the attic. Recommend pest control company to evaluate.

Recommendation: Contact a qualified professional.

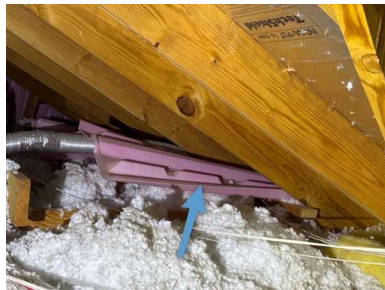
### 7: Loose/ Uninstalled Baffle

Observed one or more baffles that had become uninstalled. Baffles allow the attic space to breathe and ventilate properly. Recommend installation and or repair of baffle.

Recommendation: Contact a qualified professional.

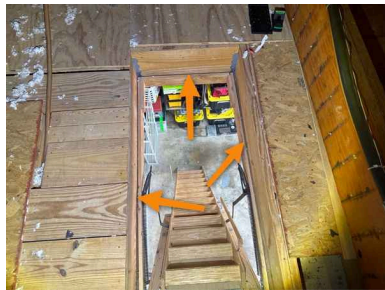
### 8: Attic Door Insulation Gap

The attic door perimeter lacks fire retardant insulation, creating a thermal bypass and potential fire pathway. This gap was observed during the attic inspection. Inadequate insulation at this location reduces energy efficiency and may compromise fire safety ratings. The perimeter should be sealed and insulated with fire-rated materials to prevent heat loss and maintain proper fire separation.

Recommendation: Contact a qualified professional.

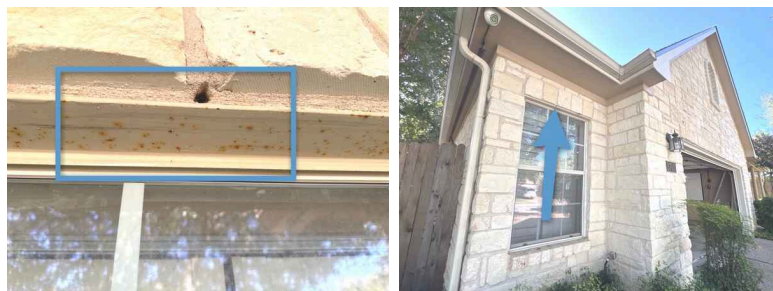
**1: Rusted or Unpainted Lintels**

Rust or missing paint was observed on the lintels. A lintel is a structural piece of material that sits flat atop and over an opening in a wall. Lintels are most commonly made from steel. If left untreated, can rust and deteriorate. How to keep your steel lintels maintained: At the first signs of rust, be sure to have your lintels scraped, painted and caulked. Scrape and sand existing rust from the lintel, coat with an exterior grade paint, caulk the joint between the lintel and material above.

Recommendation: Contact a qualified professional.

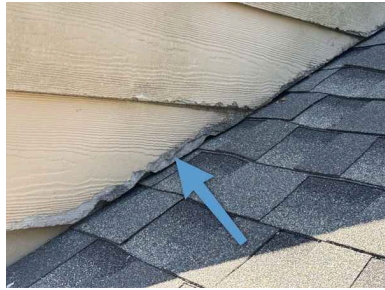
Above back porch

One or more areas of damage cement board siding were observed. Recommend repair

Recommendation: Contact a qualified professional.

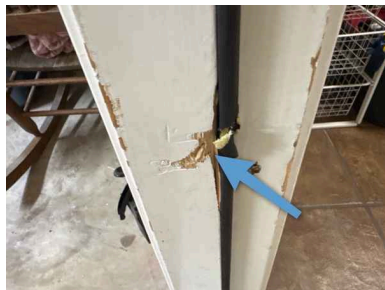
Garage entry

Loose and or damaged trim was observed in one or more areas. Recommend repair.

Recommendation: Contact a qualified professional.

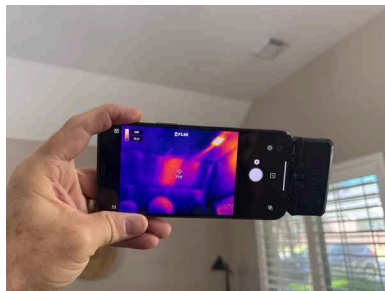
Living Room

The walls were scanned with a thermal camera. Observed what appears to be missing insulation in one or more walls. Recommend further evaluation and repair where insulation is missing.

Recommendation: Contact a qualified professional.

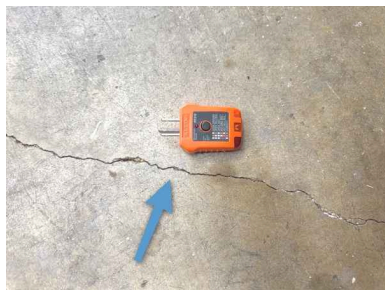
## 2: Garage Floor Cracks

Cracks observed are common in many homes, and not an indicator of major structural movement, but rather normal settling over time.

Recommendation: Contact a qualified professional.

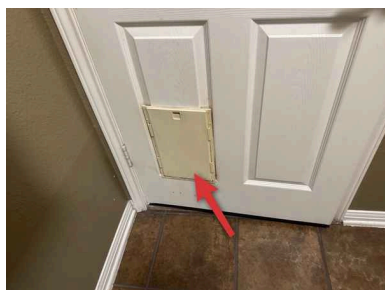
There is a opening (pet door/window) in the garage door. This negates the fire rating of the door. Garage doors should be solid to help maintain proper fire separation between the house and garage. Applicable building code: 2012 IRC: --R309.1 Opening protection. -Openings from a private garage directly into a room used for sleeping purposes shall not be permitted. Other openings between the garage and residence shall be equipped with solid wood doors not less than 13/8 inches (35 mm) in thickness, solid or honeycomb core steel doors not less than 13/8 inches (35 mm) thick, or 20-minute fire-rated doors

Recommendation: Contact a qualified professional.

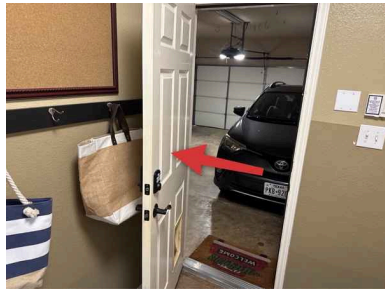
The door to the garage is not self closing. Recommend installing/activating self closing hinges for proper fire separation and carbon monoxide safety reasons as per today's standards.

Recommendation: Contact a qualified professional.

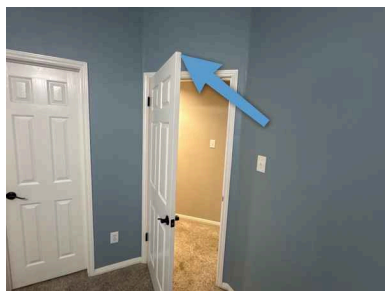
### 6: Door Rubs

One or more doors rubs the frame and or threshold when opening and closing. Recommend adjustment.

Recommendation: Contact a qualified professional.

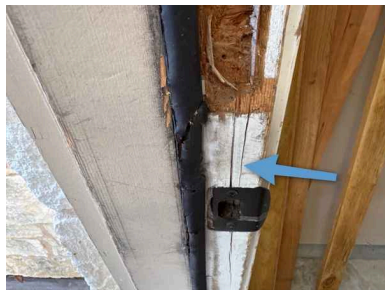
Garage

Observed one more areas with a cracked door, frame and or trim. Recommend

Recommendation: Contact a qualified professional.

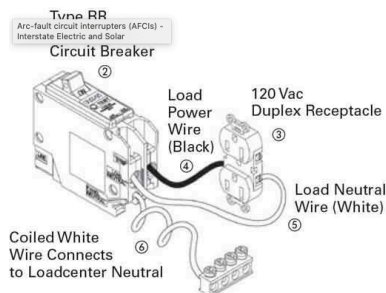
**1: No AFCI Breakers Present****➔Recommendation**

There are no Arc Fault Circuit Interrupt (AFCI) breakers present as called for by recent TREC reporting standards. AFCI breakers are used to protect living area branch circuits that are not GFCI (Ground Fault Circuit Interrupt) protected. When electric service is renovated, it is usually required to bring to service to current code required by local jurisdiction. Further evaluation by licensed electrician may be desired. This technology was not available and/or not required at time home was constructed.

Recommendation: Contact a qualified professional.

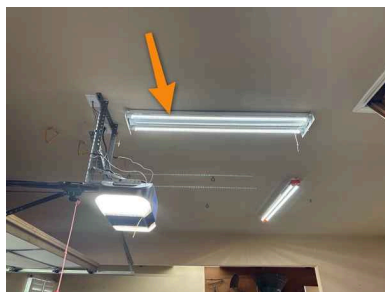
Garage

One or more lights flickered at time of inspection. Bulb replacement may only be necessary, but further evaluation recommended.

Recommendation: Contact a qualified professional.
