PRO-CERTIFIED HOME INSPECTION, PLLC

## RESIDENTIAL INSPECTION

4204 Sevilla Dr  
Georgetown, TX 78628

# PROPERTY INSPECTION REPORT FORM

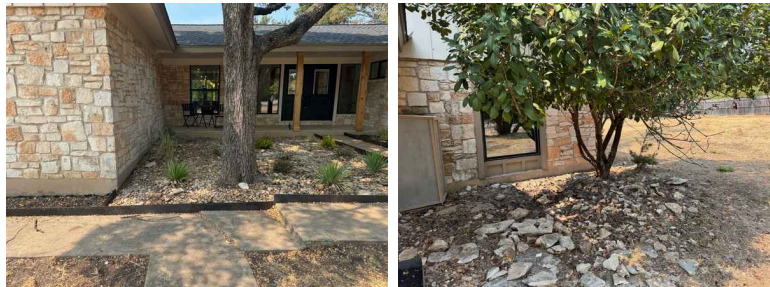
The tree near the house foundation can cause foundation movement due to the roots extracting water from the soil causing a drying or shrinking effect. You may wish to consult with a service company about installation of root barriers which may prevent feeder roots from nearby trees from migrating below the structure and extracting moisture from under the slab foundation. Root barriers are usually placed as far from the tree and as near to the foundation as possible in order to decrease damage to the tree roots.

Recommendation: Contact a qualified professional.

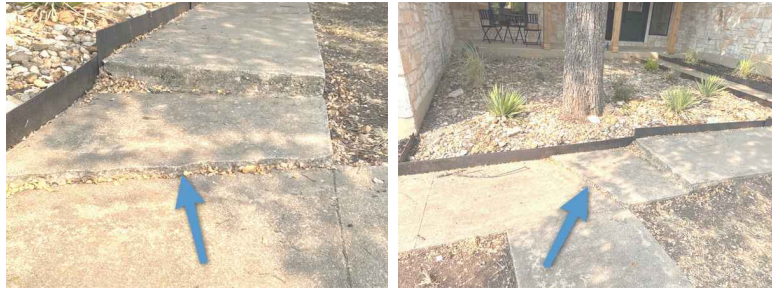
Cracks were observed at the driveway/entry walk. The cracks are normal due to seasonal differential movement and age or shrinkage cracks from curing. Repair as desired.

Recommendation: Contact a qualified professional.

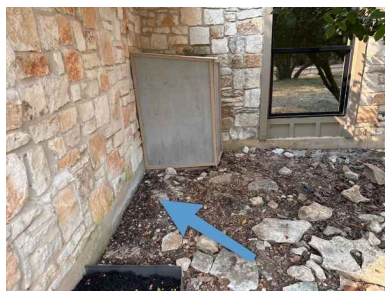
Grading is moderately sloping towards the home in some areas and/or low spots are present preventing water from adequately draining. This could lead to foundation issues. Recommend installing a gutters and or gutter extension and having a qualified contractor raise grade where low to better divert water away from foundation.

Recommendation: Contact a qualified landscaping contractor

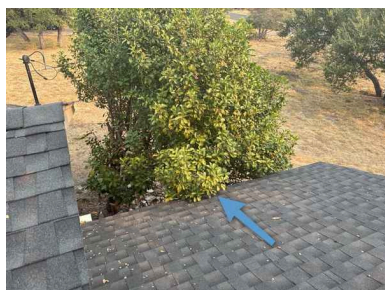
Tree limbs were observed at one or more locations to be too close or in contact with the roof surface. Recommend trimming trees a minimum of 3 feet away from the roof covering to prevent future damage. This will be ongoing maintenance.

Recommendation: Contact a qualified professional.

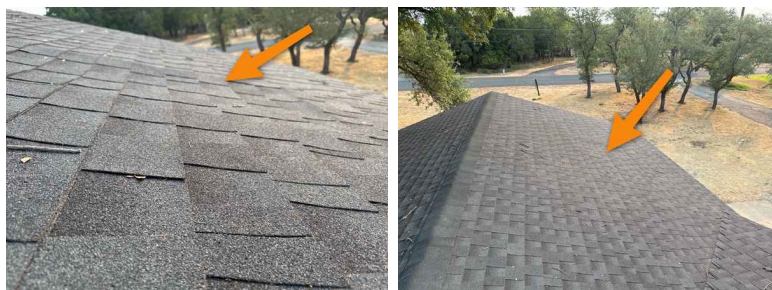
One or more low spots were observed while walking the roof. This can be caused from missing or loose decking and/or current or previous moisture damage. Recommend further evaluation.

Recommendation: Contact a qualified professional.

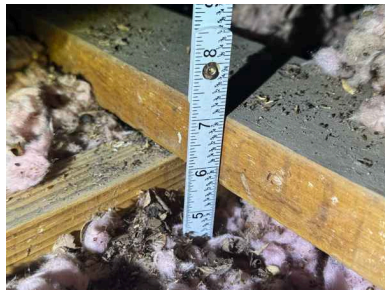
The attic insulation is below recommended levels for this climate zone. Inadequate insulation reduces the home's energy efficiency, leading to higher heating and cooling costs and potential temperature regulation issues. An insulation contractor should evaluate current R-values and recommend upgrades to meet current standards.

Recommendation: Contact a qualified insulation contractor.

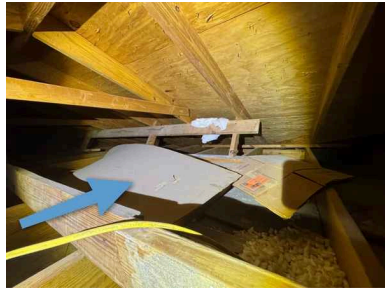
There is construction debris and/or personal property in the attic area. Remove recommended.

Recommendation: Contact a qualified professional.

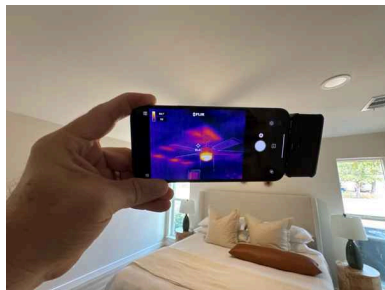
Master Bedroom

Insulation was observed to be insufficient or missing in one or more areas of the home with thermal imaging. Recommend insulation in these areas to better improve energy efficiency.

Recommendation: Contact a qualified professional.

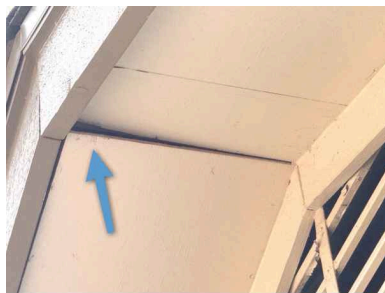
Right hand side

Soffit panels along the roof overhang are loose or missing. This allows water, pests, and debris to enter the attic and wall cavities, potentially causing rot, pest damage, and compromised insulation. Loose panels should be secured and missing sections replaced by a qualified roofer or carpenter to restore proper protection.

Recommendation: Contact a qualified professional.

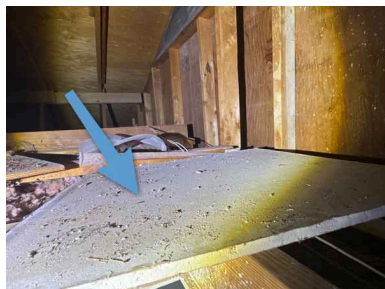
Observed one or more scuttle hatches that were missing at the time of inspection. Recommend further evaluation and repair by cutting the Sheetrock and installing a scuttle hatch for proper access.

Recommendation: Contact a qualified professional.

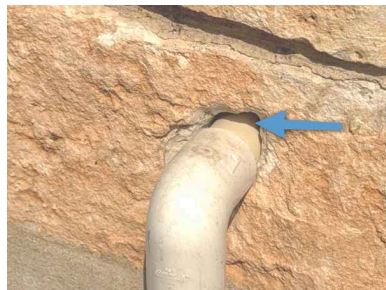
There were one or more areas where a penetration of the wall was not sealed correctly. Recommend sealing the areas to prevent water intrusion and the possibly of rodents and pests getting into the wall cavity and attic area. Photos are a sampling of wall penetrations.

Recommendation: Contact a handyman or DIY project

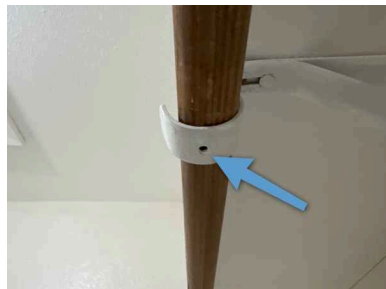
One or more closet rods are missing fasteners. Install as necessary.

Recommendation: Contact a qualified handyman.

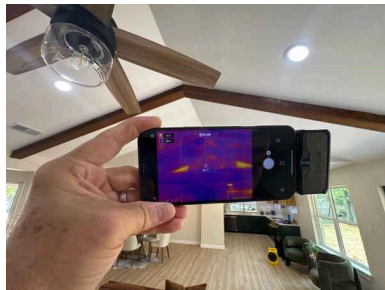
Front bedroom on right

The walls were scanned with a thermal camera. Observed what appears to be missing insulation in one or more walls. Recommend further evaluation and repair where insulation is missing.

Recommendation: Contact a qualified professional.

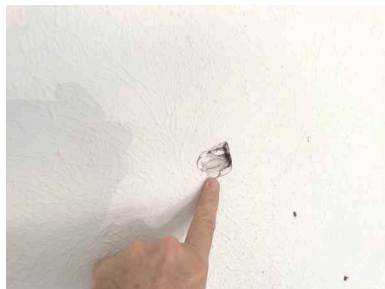
Garage

One or more locations with minor drywall damage.

Recommendation: Contact a qualified professional.

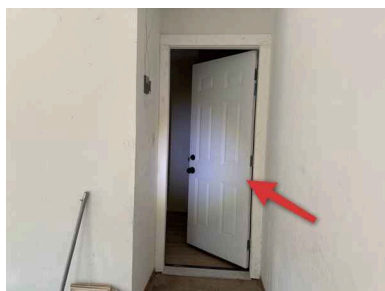
The door to the garage is not self closing. Recommend installing/activating self closing hinges for proper fire separation and carbon monoxide safety reasons as per today's standards.

Recommendation: Contact a qualified professional.

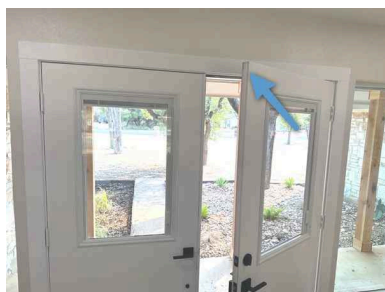
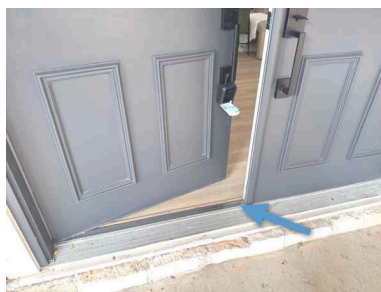
One or more doors rubs the frame and or threshold when opening and closing. Recommend adjustment.

Recommendation: Contact a qualified professional.

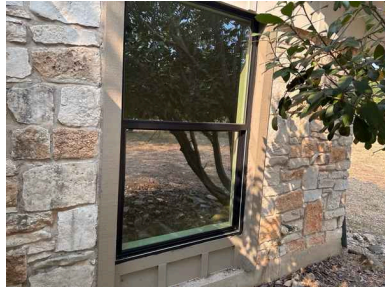
One or more windows are missing a screen. Recommend seller/builder re-hang and /or replace screens where needed before closing.

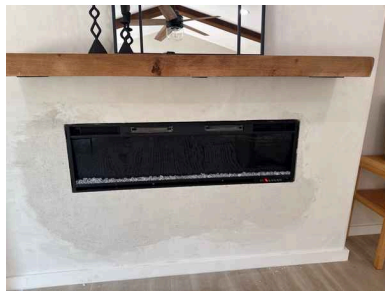
The fireplace did not activate. Recommend further evaluation by a qualified contractor.

Recommendation: Contact a qualified professional.

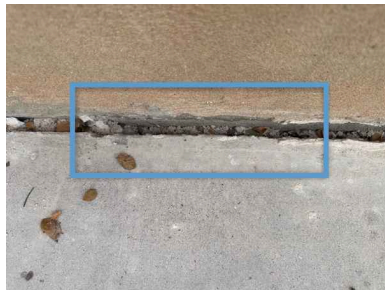
The slab joint between the house and flatwork should be sealed. This separation may allow moisture to wick into the soil near the foundation and could cause expansion of the soil, which may cause settling to occur. Further evaluation and/or repair by a qualified contractor is recommended.

Recommendation: Contact a qualified professional.

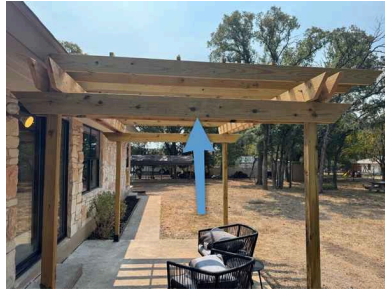
The wooden patio framing structure is unpainted and unstained, leaving the raw lumber fully exposed to the elements. Unprotected exterior wood is susceptible to moisture damage, weathering, checking, and premature wood rot or decay over time. Have a qualified professional clean and apply a protective paint or exterior-grade sealant/stain to preserve the structural integrity and lifespan of the wood.

Recommendation: Contact a qualified professional.

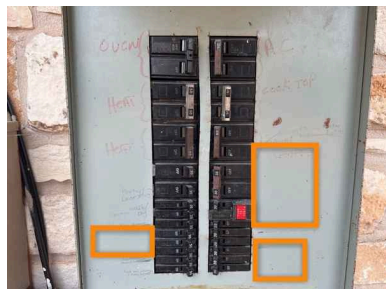
Electrical panel has faded and or missing labels. Recommend a qualified electrician test and properly label all switches.

Recommendation: Contact a qualified electrical contractor.

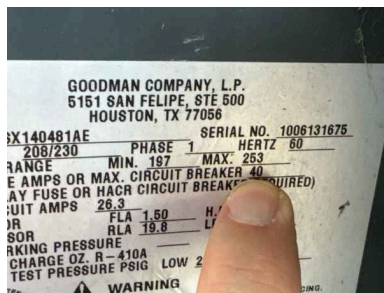
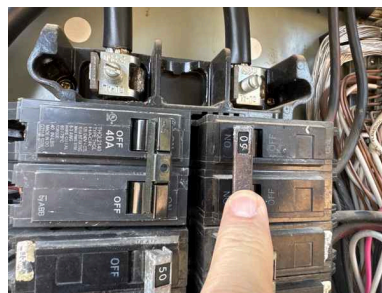
The breaker for the condensing unit is over-sized per the manufacturer's identification tag. Further evaluation and/or repair by a licensed electrician is advised. This is common when equipment is updated and is an easy low expense repair that usually only requires a breaker swap out.

Recommendation: Contact a qualified professional.

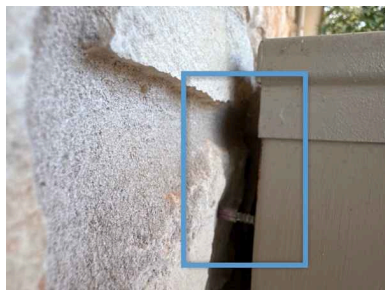
The exterior electric panel and/or meter panel is not sealed to the wall. Recommend sealing to prevent water intrusion into the panel.

Recommendation: Contact a qualified professional.

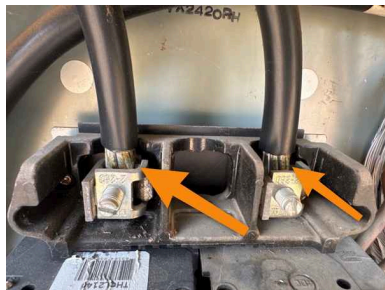
Antioxidant paste missing at main service conductors. Add as needed. This helps protect wires from oxidation and movement.

Recommendation: Contact a qualified professional.
