## RESIDENTIAL INSPECTION

516 Independence Creek Ln  
Georgetown, TX 78633

# PROPERTY INSPECTION REPORT FORM

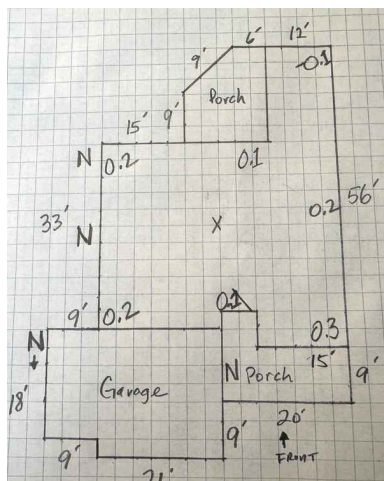
*Foundation Measurements:*

Elevation measurements were taken using a digital level at the first floor. It should be noted that some foundations may be unlevel due to workmanship when the foundation was placed. The below measurements do not necessarily show the actual deflection from differential movement.

Foundation is performing within industry accepted standards. Maintaining soil moisture content near foundation, positive drainage away from foundation and having gutters that drain water away from the foundation is the best defense against future settlement.

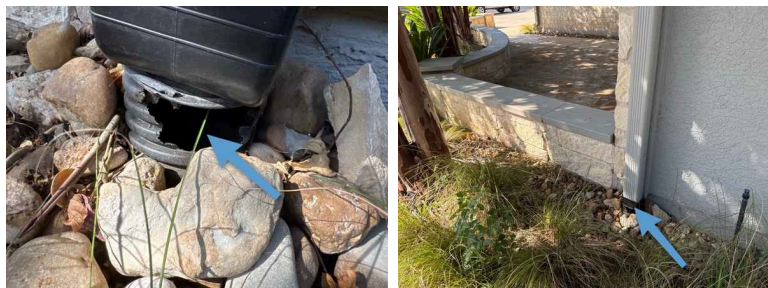
**1: Damaged Gutters/Downspouts***🔧 Maintenance Item*

The roof gutters/downspouts are dented and/or damaged at one or more locations. This can result in gutter overflow and/or improper drainage in those areas. Recommend repair or replacement as necessary.

Recommendation: Contact a qualified gutter contractor

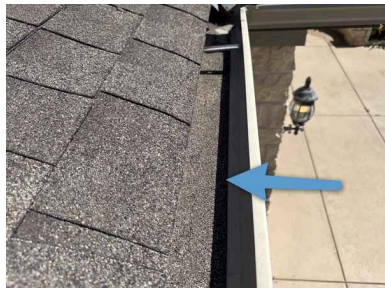
**2: Shingle Granules in Gutters***🔧 Maintenance Item*

Roof granules were observed in the roof gutters at one or more locations. This can restrict drainage and cause the gutters to rust. It is recommended the gutters be cleaned and adjusted as necessary to ensure proper drainage.

Recommendation: Contact a handyman or DIY project

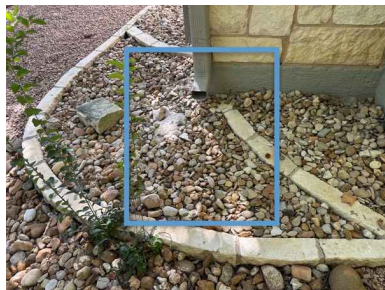
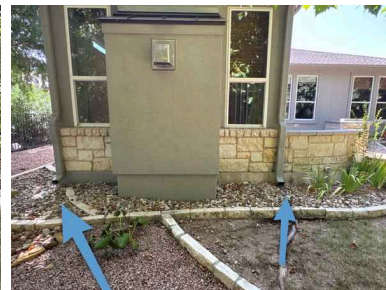
### 3: Debris in Gutters

Debris was observed in the gutters at one or more locations. It is recommended to clean the gutters to allow water to flow freely to the downspouts.

Recommendation: Contact a qualified professional.

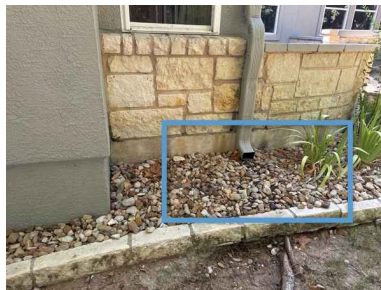
Observed one or more areas of possible pooling water. Recommend installing soil or appropriate aggregate in these areas so that water does not pool next to the foundation and cause settling of the foundation.

Recommendation: Contact a qualified professional.

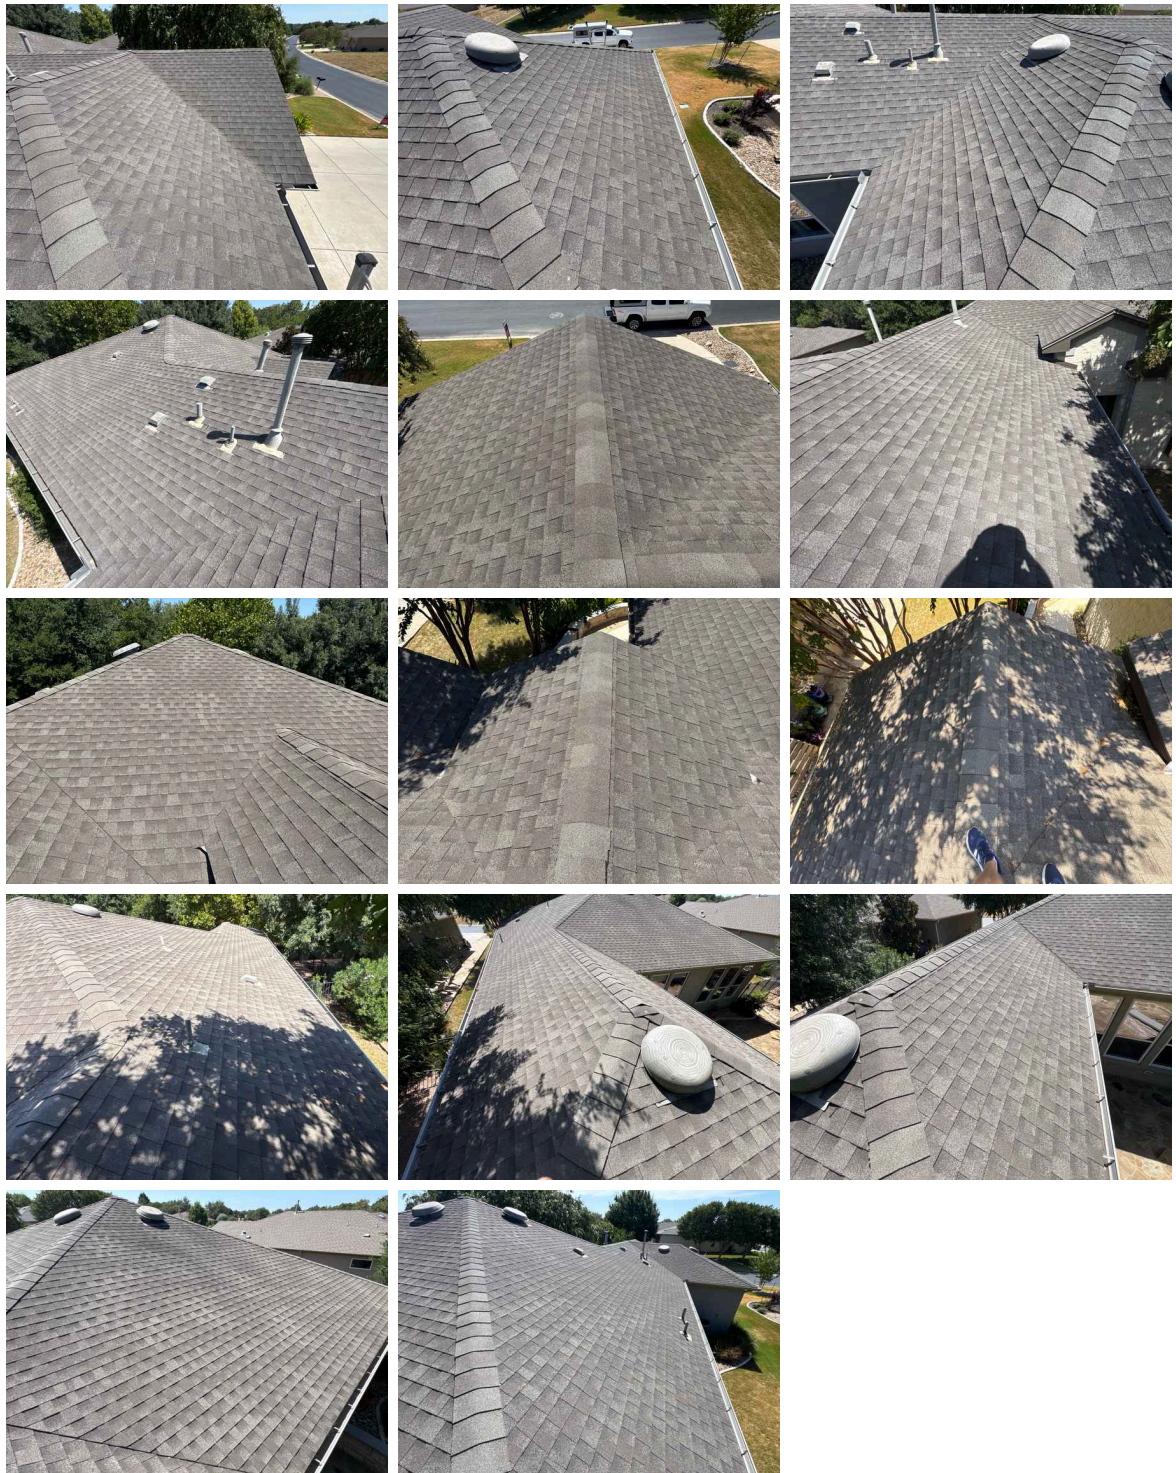
*Roof Condition Photos:*

*Condition of Roof Covering:* Aged Condition, Minor Damage

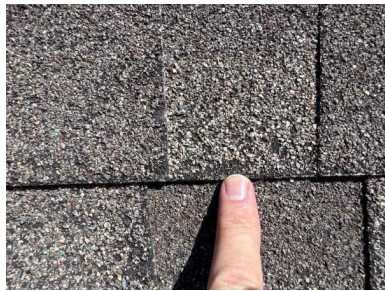
Loss of granules was observed at one or more locations. Roof granule loss due to normal aging occurs over the life of an asphalt shingle roof as weather and sun exposure cause the roof shingle to lose its flexibility, as the roof is exposed to changing temperatures, humidity, etc. This may indicate the roof covering is in the last half of its useful life.

Recommendation: Contact a qualified professional.

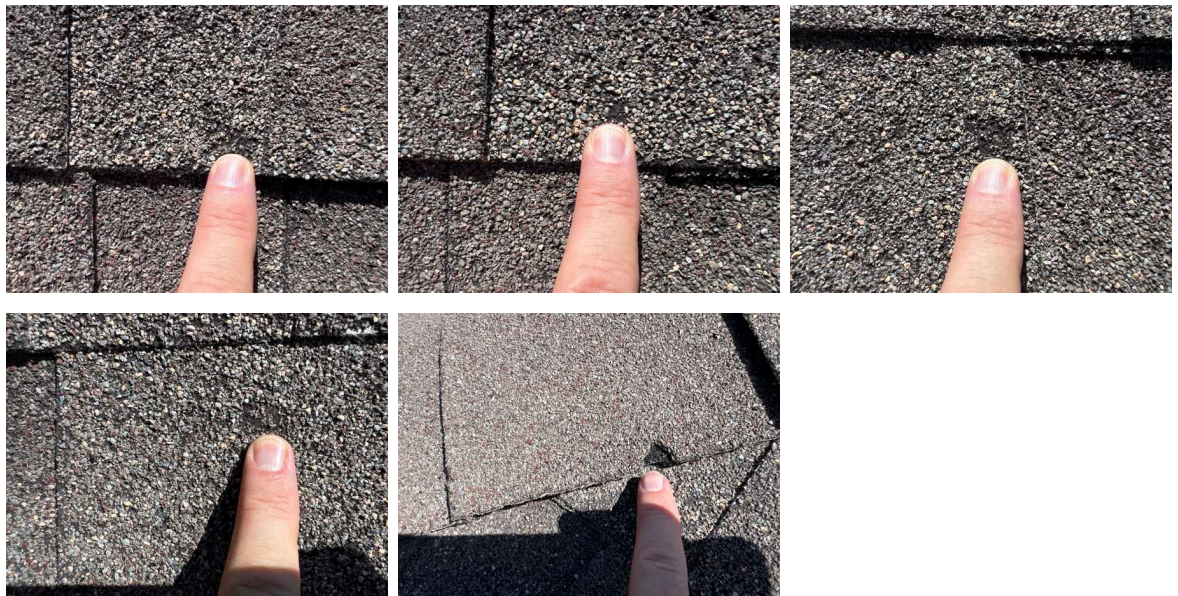
## 2: Impact Damage

Impact damage to the shingles was observed at one or more locations. The areas could be caused by hail or debris from nearby trees. In my opinion, the roof appears to be serviceable. However, even minimal and/or a small number of impacted shingles can affect the insurability of the roof, which cannot be guaranteed by the inspector. It is recommended the roof be inspected and repaired as necessary by a professional roofing contractor.

Recommendation: Contact a qualified roofing professional.

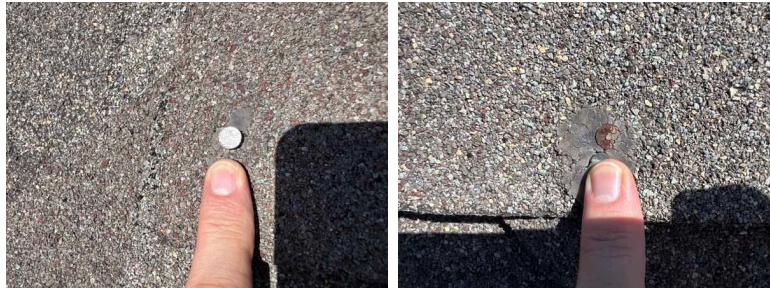
## 3: Exposed Fasteners

One or more areas of the roof coverings have fasteners that are not sealed. Seal to prevent moisture intrusion. Recommend repair by a qualified person.

Recommendation: Contact a qualified professional.

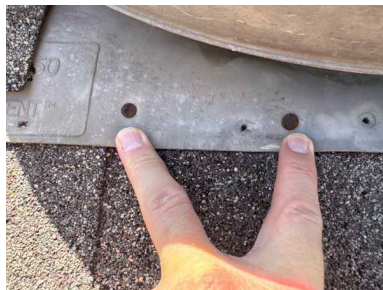
#### 4: Flashing Fastner missing sealant

Observed one or more flashing fasteners that were missing sealant. This could cause a leak in the roof. Recommend sealing all flashing fasteners.

Recommendation: Contact a qualified professional.

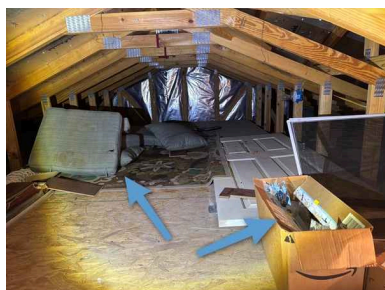
There is construction debris and/or personal property in the attic area. Remove recommended.

Recommendation: Contact a qualified professional.

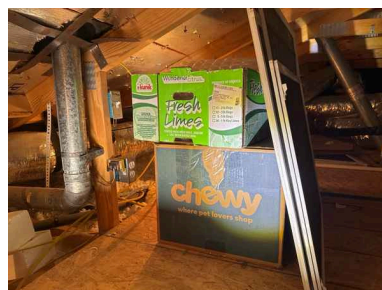
## 1: Debris in Attic

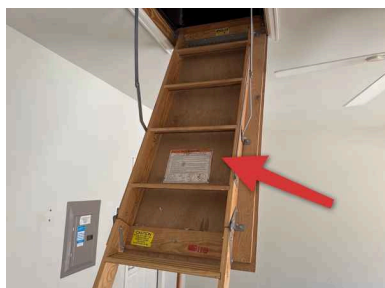
## 2: Attic Ladder Door Not Fire Rated

The attic access ladder door is not fire-rated. Fire-rated doors are designed to resist flame spread and limit heat transfer during a fire, providing critical protection for occupants. This non-compliant condition should be evaluated by a qualified professional to determine if replacement with an approved fire-rated door is necessary.

Recommendation: Contact a qualified professional.

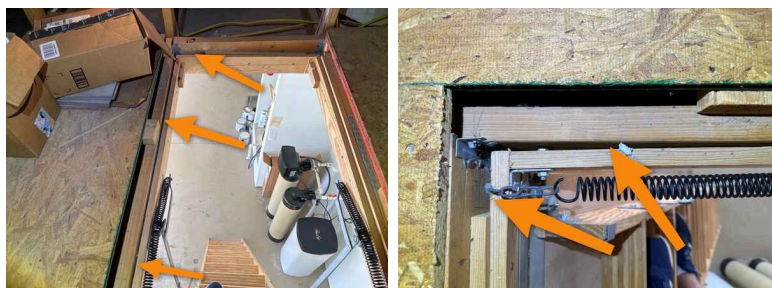
### 3: Attic Door Insulation Gap

The attic door perimeter lacks fire retardant insulation, creating a thermal bypass and potential fire pathway. This gap was observed during the attic inspection. Inadequate insulation at this location reduces energy efficiency and may compromise fire safety ratings. The perimeter should be sealed and insulated with fire-rated materials to prevent heat loss and maintain proper fire separation.

Recommendation: Contact a qualified professional.

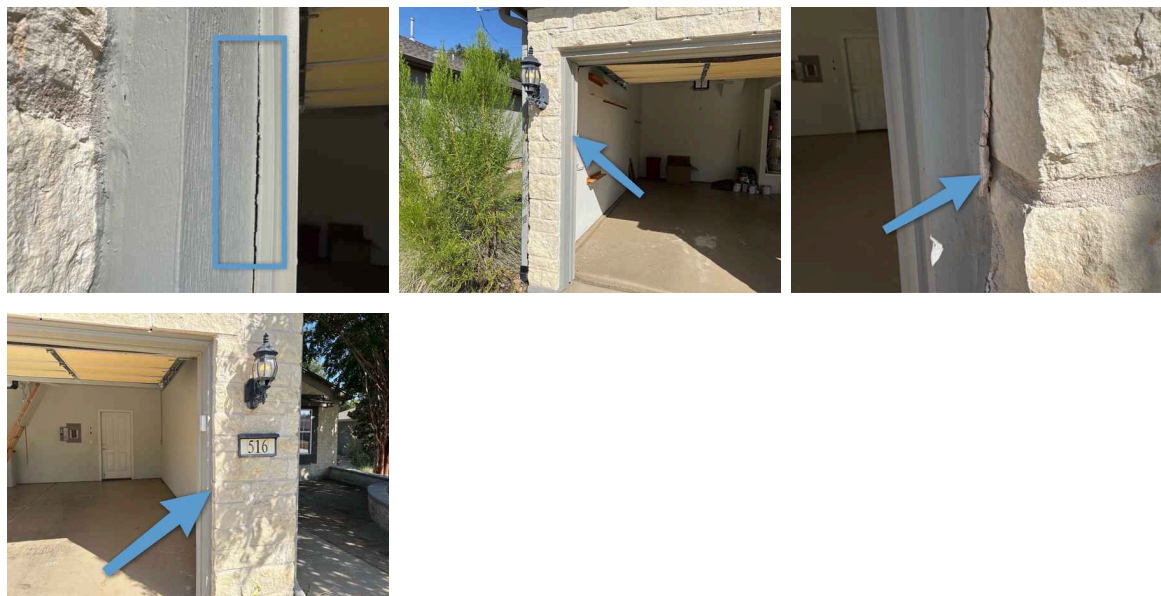
## 1: Caulk / Seal Exterior Trim

Caulk was noted to be deteriorated or missing at one or more exterior locations. Recommend sealing the areas to prevent moisture intrusion and possible moisture damage. This will be ongoing maintenance.

Recommendation: Contact a qualified professional.

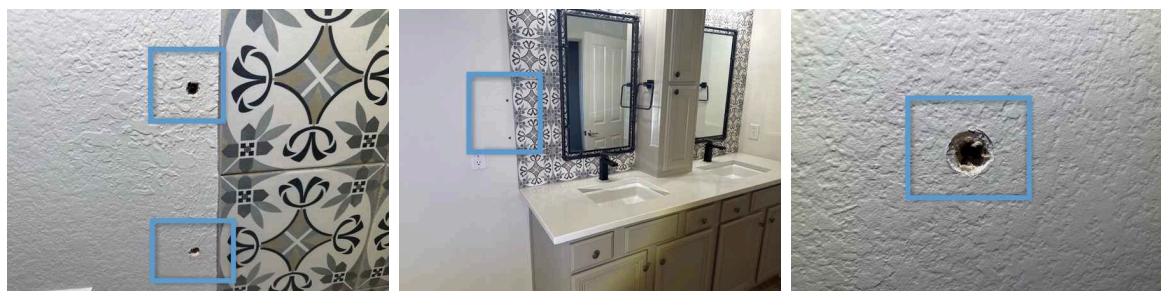
## 2: Minor Drywall Damage

One or more locations with minor drywall damage.

Recommendation: Contact a qualified professional.

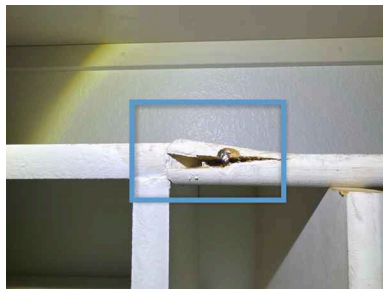
Master closet

Observed one or more damaged shelves. Recommend repair.

Recommendation: Contact a qualified professional.

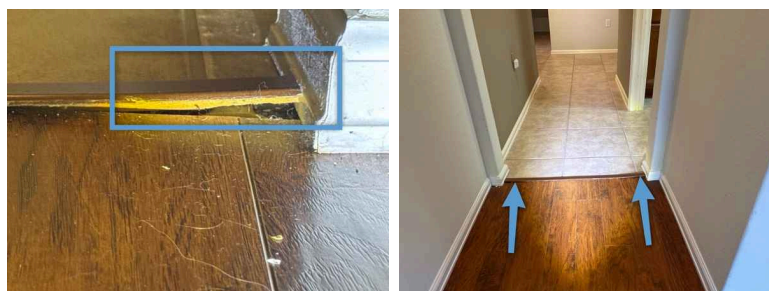
## 1: Loose/Damaged Transition Strip

One or more transition strips were observed to be loose or damaged. Recommend repair or replacement.

Recommendation: Contact a qualified professional.

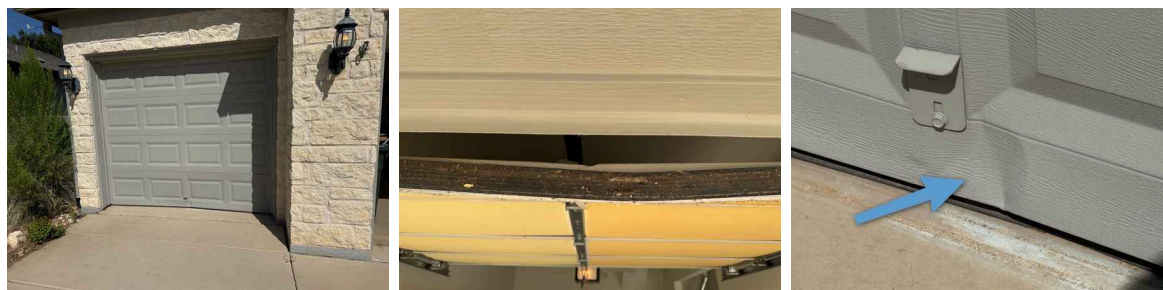
### 1: Garage Door Dent/Crack in Panel

Dents and/or cracks observed at the garage overhead door in one or more panels. Repair or replace as necessary.

Recommendation: Contact a qualified professional.

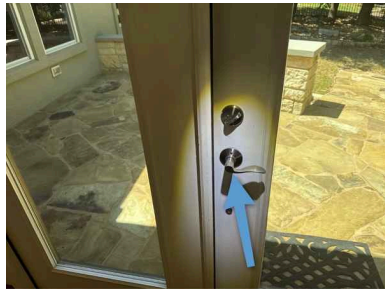
**3: Loose Hardware**

One or more doors and/or door jambs have loose or missing hardware. Repair or replace as necessary.

Recommendation: Contact a qualified handyman.

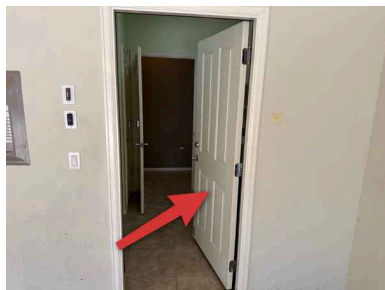
**4: Garage Entry Door Not Self Closing**

The door to the garage is not self closing. Recommend installing/activating self closing hinges for proper fire separation and carbon monoxide safety reasons as per today's standards.

Recommendation: Contact a qualified professional.

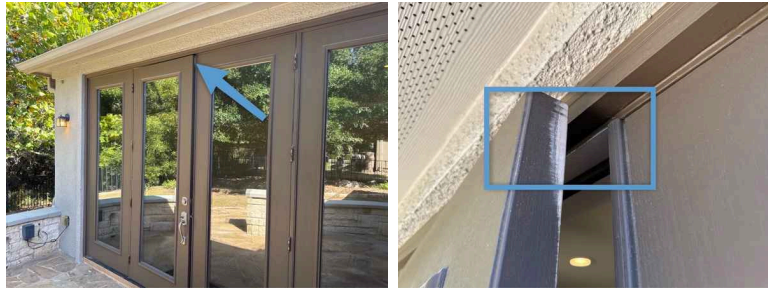
**5: Door Rubs**

One or more doors rubs the frame and or threshold when opening and closing. Recommend adjustment.

Recommendation: Contact a qualified professional.

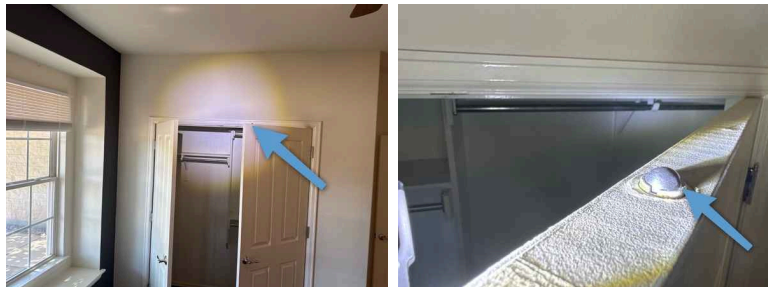
## 6: Adjust Ball Catch

Observed one or more doors that need adjustment at the ball latch. Recommend repair.

Recommendation: Contact a qualified professional.

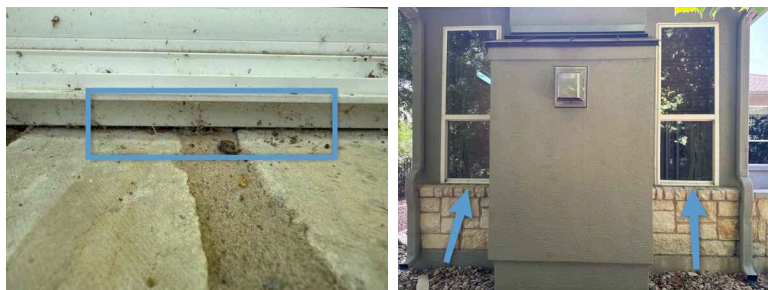
### 1: Window Caulk Missing/Deteriorated

One or more windows were observed to have missing and/or deteriorated caulk. Recommend sealing these areas to avoid water intrusion. This will be ongoing maintenance.

Recommendation: Contact a qualified professional.

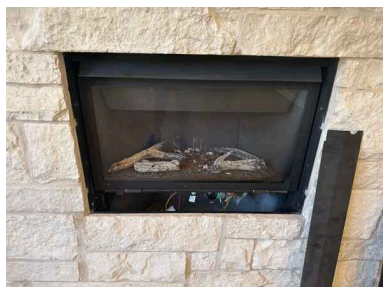
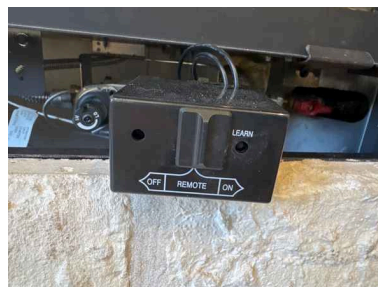
**1: Did not Activate**

The fireplace did not activate. Recommend further evaluation by a qualified contractor.

Possible dead battery

Recommendation: Contact a qualified professional.

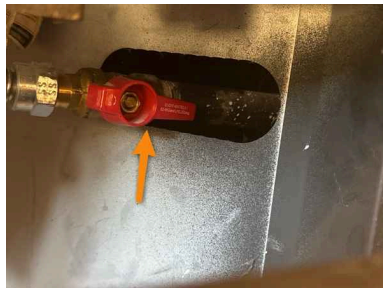
Gas valve turned on

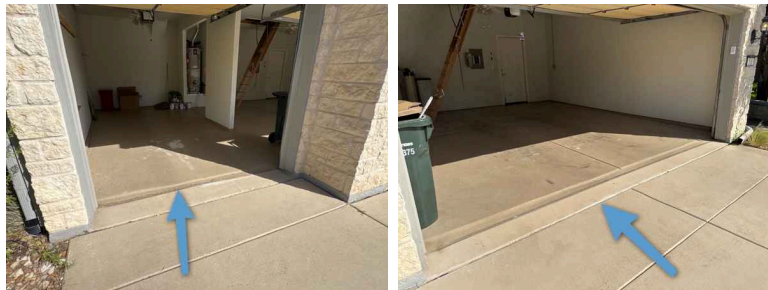
The slab joint between the house and flatwork should be sealed. This separation may allow moisture to wick into the soil near the foundation and could cause expansion of the soil, which may cause settling to occur. Further evaluation and/or repair by a qualified contractor is recommended.

Recommendation: Contact a qualified professional.

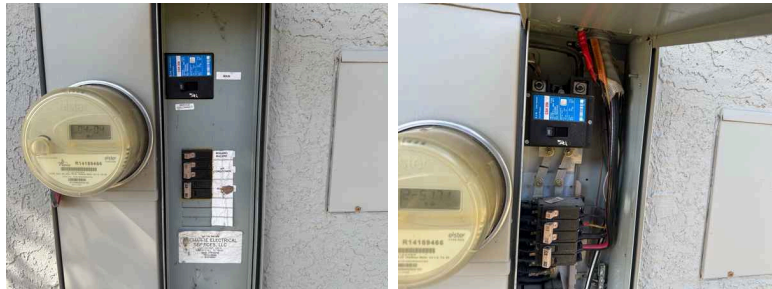
*Location of Main Panel:* Exterior of Home

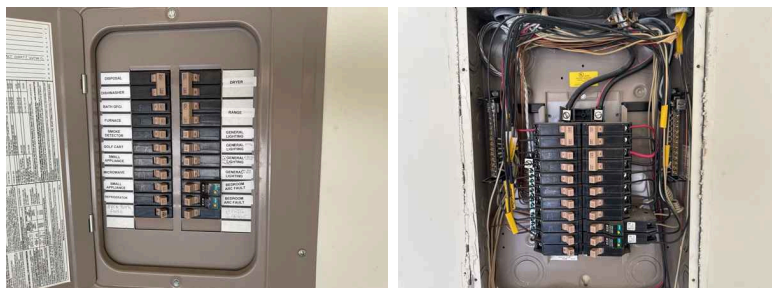
*Subpanel Location:* Garage

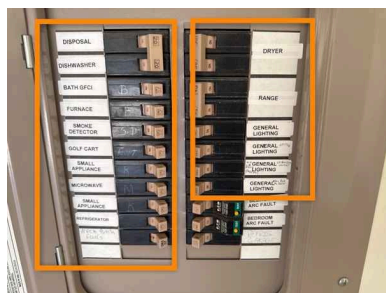
## 1: Partial AFCI Breakers

Observed only partial AFCI breakers at the panel. The updated electrical code requires AFCI breakers at the panel to be up to today's current code. Consider installing additional AFCI breakers where needed to protect the structure from possible electrical arcs, and the possibility of an electrical fire.

**Recommendation:** Contact a qualified professional.

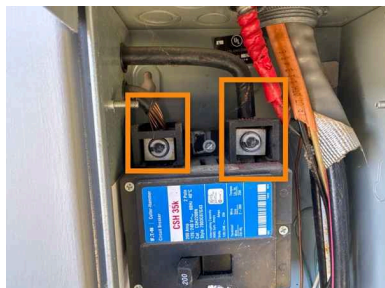
Main electrical panel

### 3: Missing Service Entrance Lug Covers

Service entrance lug covers are missing from the electrical service panel. These protective covers shield live electrical connections from accidental contact during maintenance or inspection. Exposed lugs present a significant shock and electrocution hazard to anyone working near the panel. Have a qualified electrical contractor install appropriate lug covers to safely protect these connections.

Recommendation: Contact a qualified professional.

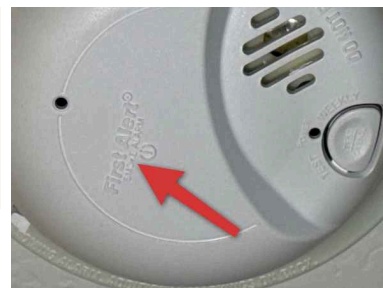
Outside master bedroom

**1: Carbon Monoxide Detector Missing****⚠️Safety Hazard**

Carbon monoxide detector is not present at time of inspection. Alarms in place are smoke alarms only. Recommend installing a carbon monoxide/smoke detector combo unit. One is required at every floor when there are gas appliances installed and or an attached garage. See diagram below for proper placement.

Recommendation: Contact a qualified professional.

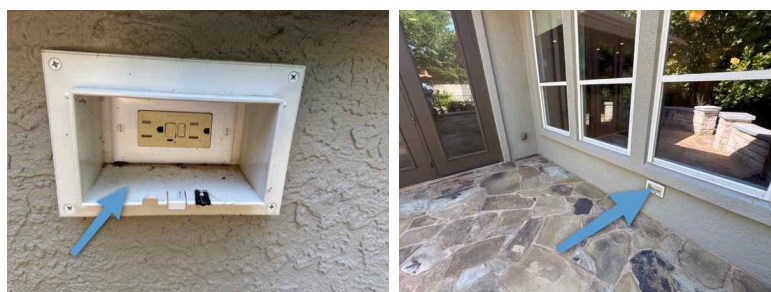
Back porch

### 3: Missing or Damaged Weather Covers

Electrical outlets and fixtures exposed to weather lack protective covers or have damaged covers. This allows moisture and debris to enter electrical components, creating potential shock hazards and equipment damage. Install new weather-resistant covers or repair damaged ones to protect all exterior electrical devices.

Recommendation: Contact a qualified professional.

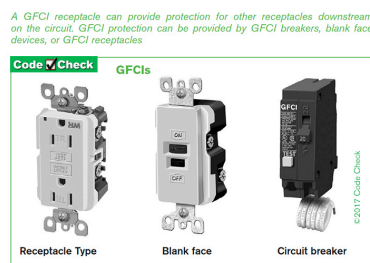
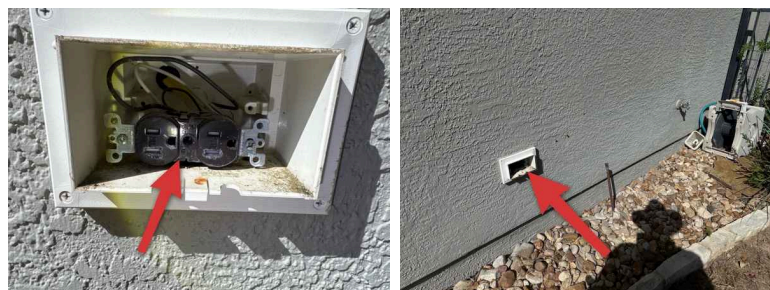
### 4: GFCI Missing in Required Locations

GFCI outlets protect people from electric shock. Recommend installing correct outlets in required areas for safety reasons.

Recommendation: Contact a qualified professional.

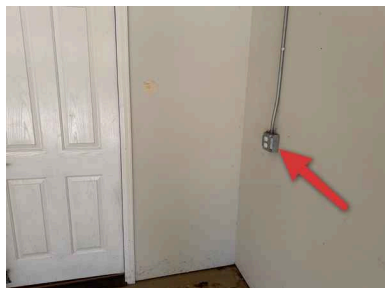
Garage

### 5: Light Fixture not Secure / Loose

One or more light fixtures are not secure. Recommend securing light fixture for proper operation.

Recommendation: Contact a qualified professional.

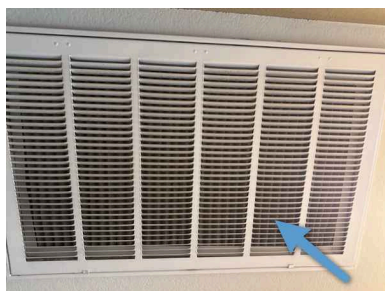
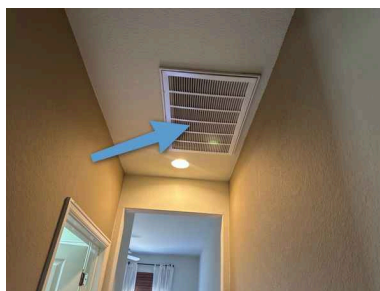
#### 1: Dirty Filter

One or more filters were observed to be dirty and should be replaced or cleaned. The fresh air filter should be cleaned every six months. The 4 inch filter at the unit should be replaced every six months and the 1 inch filter at the return air inside the house should be replaced every 30 days.

Recommendation: Contact a handyman or DIY project

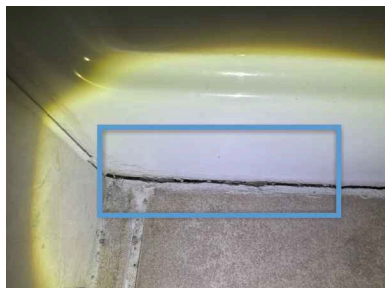
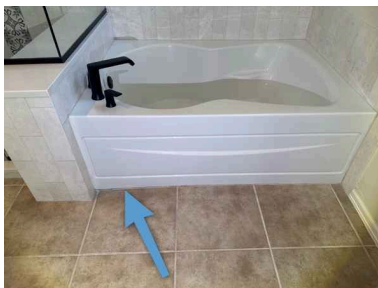
Master Bathroom

#### **1: Tub not Sealed to Floor**

Recommendation: Contact a qualified professional.

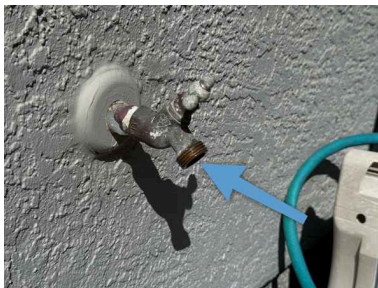
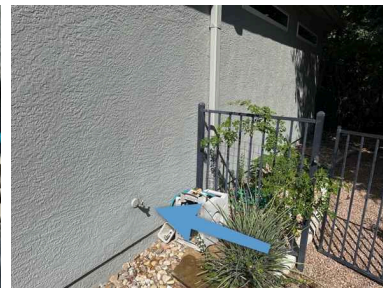
## 2: Missing Anti-Siphon @ Hose Bibs

One or more exterior faucets are missing anti siphon devices. Recommend installing as necessary to prevent possible back flow into water supply.

Recommendation: Contact a handyman or DIY project

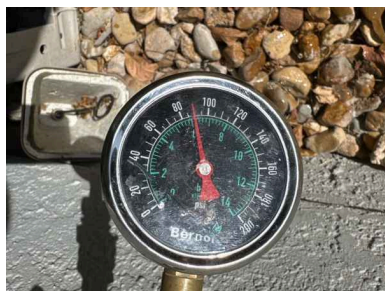
## 3: High Water Pressure

Normal operating range is 40-80PSI. The pressure reducing valve needs to be adjusted.

Recommendation: Contact a qualified professional.

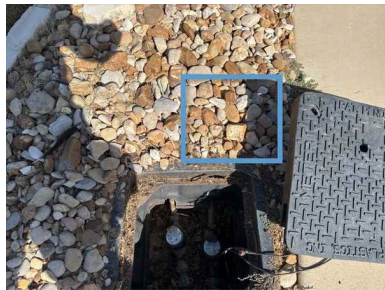
## 4: Homeowner Shutoff Buried

The main water disconnect valve is covered with soil. Recommend uncovering for easy access.

Recommendation: Recommended DIY Project

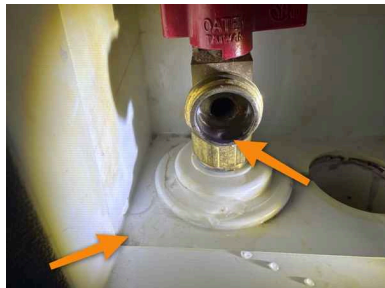
Washing machine connection

## 5: Leaking Faucet

A leak was observed at the faucet during plumbing system inspection. Leaks at faucet connections or valve seats waste water and can lead to water damage, mold growth, and increased water bills if left unaddressed. A qualified plumber should evaluate and repair the leak, which may involve tightening connections, replacing washers, or repairing internal valve components.

Recommendation: Contact a qualified professional.

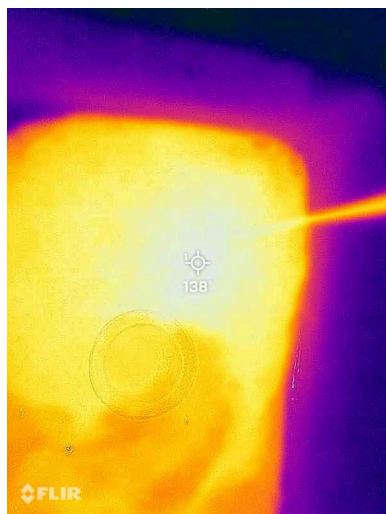
138°

**1: Water Temperature too High****▲Safety Hazard**

The water temperature is excessive and set too high. Temperatures above 120 could lead to scalding. Recommend setting the water temperature below 120 degrees for safety reasons.

Recommendation: Contact a qualified professional.

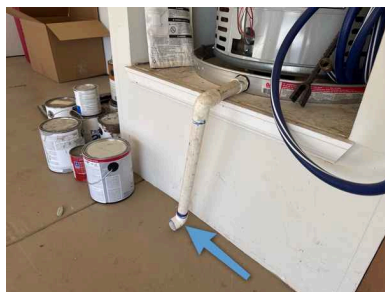
## 2: Water Heater Pan Not Draining to Exterior

The water heater drain pan is not connected to drain to the exterior of the home. This pan is designed to catch water from potential leaks or condensation and direct it safely outside. Without proper drainage, water accumulation in the pan can lead to water damage to flooring and surrounding structures. A plumbing contractor should install proper drainage piping from the pan to the exterior or to an appropriate drain location.

Recommendation: Contact a qualified professional.

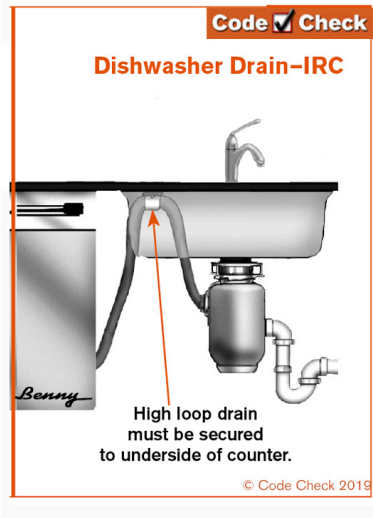
#### 1: Improper Backflow Prevention

The dishwasher drain is not properly installed which can cause sink water to flow into the dishwasher. Recommend proper installation. Refer to high loop diagram below.

Recommendation: Contact a handyman or DIY project

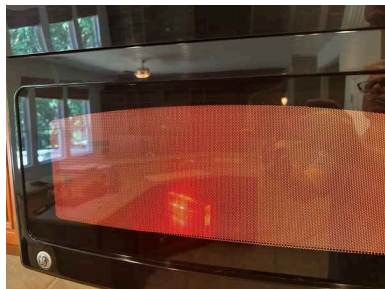
The microwave was tested by using a "microwave magic light" which is a filament that lights up when heated by the microwave energy. The microwave was heating and operating properly at the time of the inspection. Some microwaves heat more quickly than others.

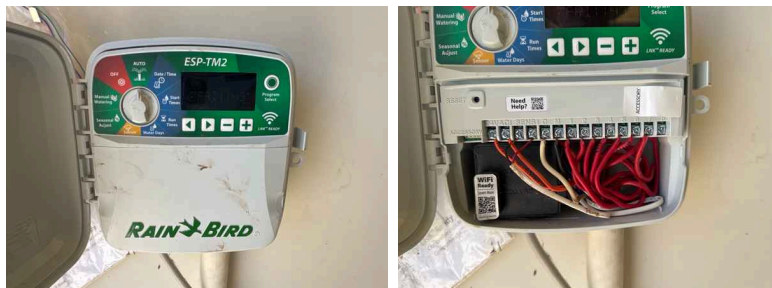
The sprinkler control panel is located in the garage. The sprinkler system consists of 7 watering areas or zones.

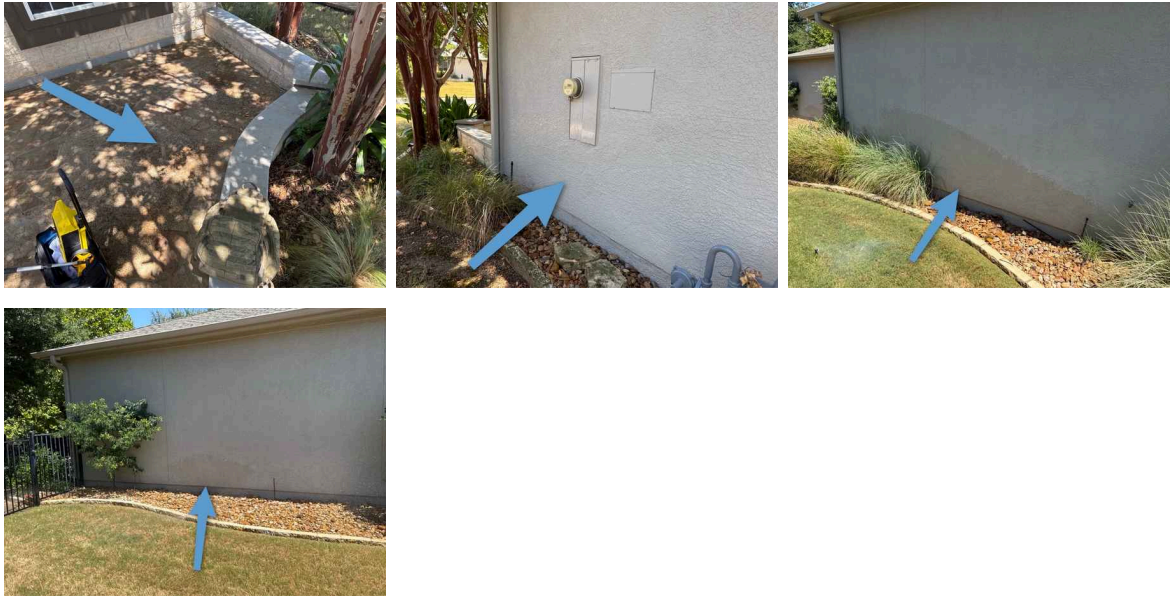
### 1: Overspray Observed

Overspray was observed at one or more locations. It is recommended that no water overspray onto driveways, sidewalks, the structure, or the fence. This could lead to premature deterioration. Recommend adjustment by a qualified technician.

Recommendation: Contact a qualified professional.

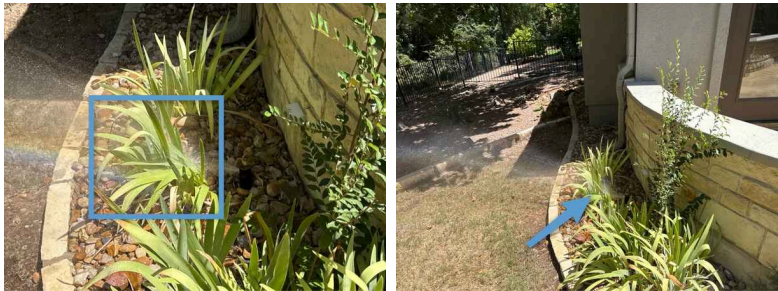
**2: Sprinkler Obstructed**

Sprinkler pop-up head is obstructed. Further evaluation and correction needed.

Recommendation: Contact a qualified professional.
