PRO-CERTIFIED HOME INSPECTION, PLLC

## RESIDENTIAL INSPECTION

2705 Wolkin Cove  
Round Rock, TX 78681

# PROPERTY INSPECTION REPORT FORM

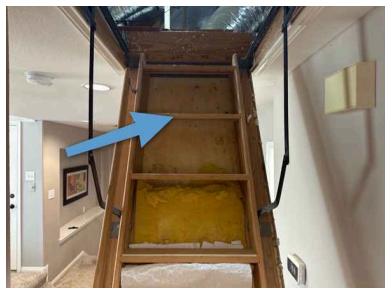
2nd Floor Attic

**3: Attic Ladder Door Not Fire Rated****▲Safety Hazard**

The attic access ladder door is not fire-rated. Fire-rated doors are designed to resist flame spread and limit heat transfer during a fire, providing critical protection for occupants. This non-compliant condition should be evaluated by a qualified professional to determine if replacement with an approved fire-rated door is necessary.

Recommendation: Contact a qualified professional.

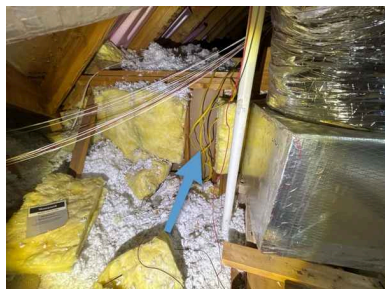
2nd Floor Attic

Observed one of our areas with loose insulation. Recommend repair.

Recommendation: Contact a qualified professional.

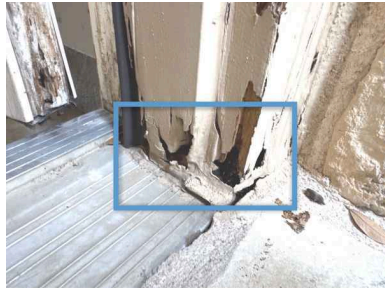
Garage

Moisture damage was observed at one or more locations of the exterior trim. Repair as necessary.

Recommendation: Contact a qualified professional.

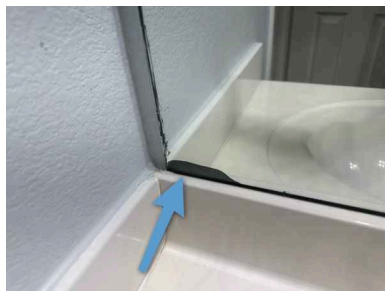
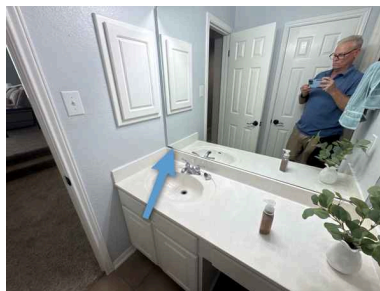
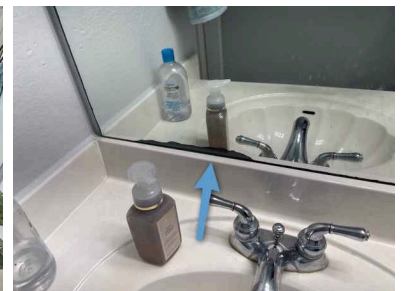
2nd Floor Bathroom

One or more mirrors show signs of delamination. Repair or replace as desired.

Recommendation: Contact a qualified professional.

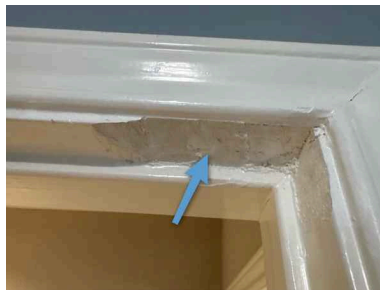
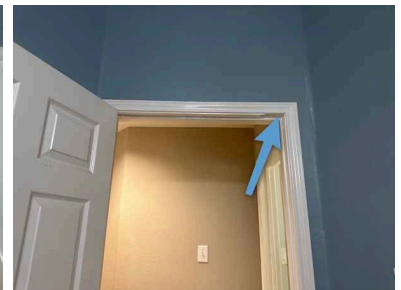
2nd Floor Bedroom

Loose and or damaged trim was observed in one or more areas. Recommend repair.

Recommendation: Contact a qualified professional.

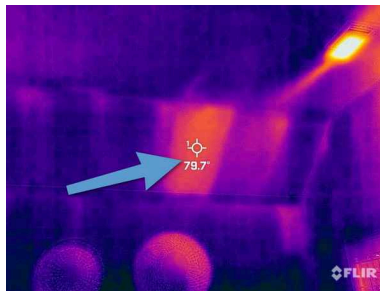
Living Room

The walls were scanned with a thermal camera. Observed what appears to be missing insulation in one or more walls. Recommend further evaluation and repair where insulation is missing.

Recommendation: Contact a qualified professional.

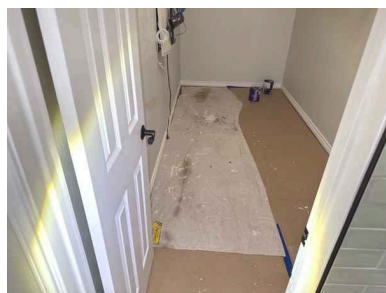
Master closet

The flooring was covered at the time of the inspection and could not be observed.

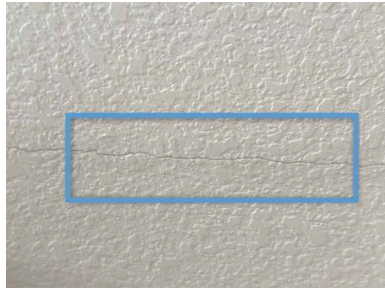
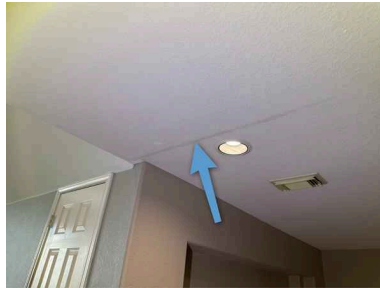
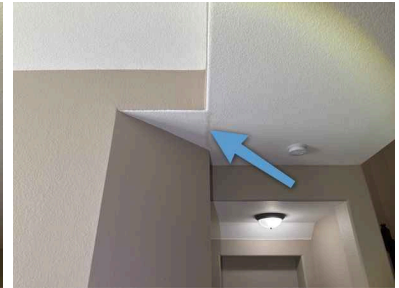
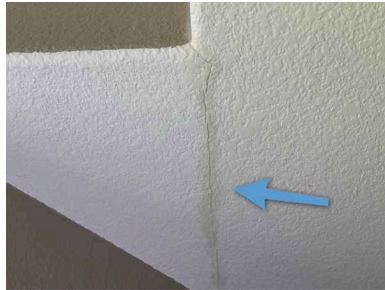
2nd Floor hallway

Settlement cracks were observed at one or more locations of the ceiling. This is due to settling, vibration, humidity, and age of the home. Repair as desired.

Recommendation: Contact a qualified professional.

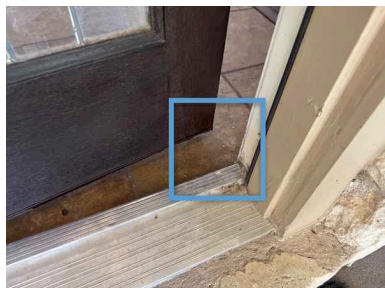
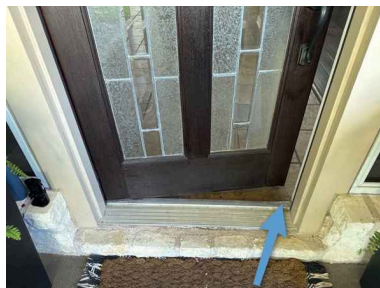
Front door

Door sticks and is tough to open. Recommend adjusting as needed.

Recommendation: Contact a handyman or DIY project

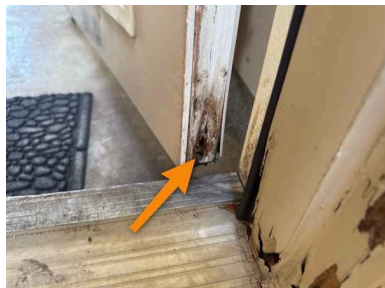
Garage

Moisture damage was observed at one or more of the exterior doors. Repair or replace as necessary.

Recommendation: Contact a qualified professional.

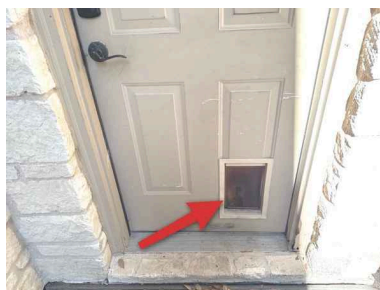
There is a opening (pet door/window) in the garage door. This negates the fire rating of the door. Garage doors should be solid to help maintain proper fire separation between the house and garage. Applicable building code: 2012 IRC: --R309.1 Opening protection. -Openings from a private garage directly into a room used for sleeping purposes shall not be permitted. Other openings between the garage and residence shall be equipped with solid wood doors not less than 13/8 inches (35 mm) in thickness, solid or honeycomb core steel doors not less than 13/8 inches (35 mm) thick, or 20-minute fire-rated doors

Recommendation: Contact a qualified professional.

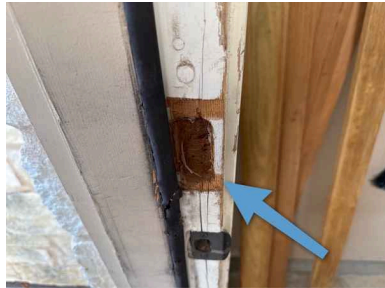
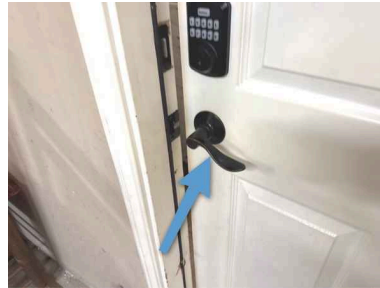
Garage

One or more doors and/or door jambs have loose or missing hardware. Repair or replace as necessary.

Recommendation: Contact a qualified handyman.

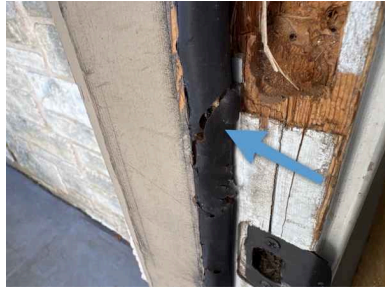
Weatherstripping was observed to be damaged at one or more locations. Recommend replacement.

Recommendation: Recommended DIY Project

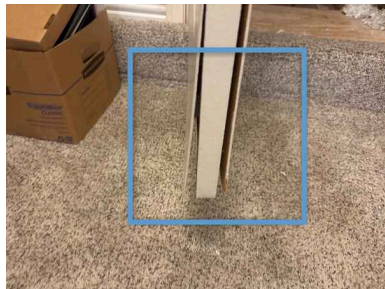
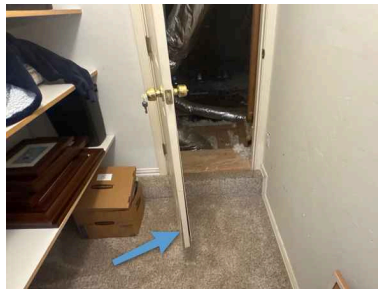
2nd Floor

One or more doors show signs of damage. Repair or replace as necessary.

Recommendation: Contact a qualified professional.

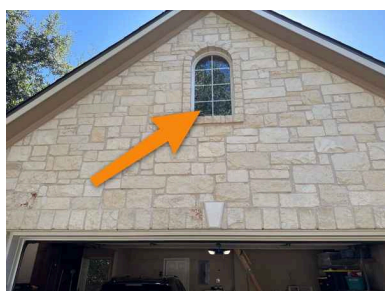
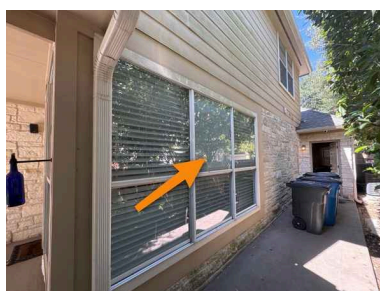
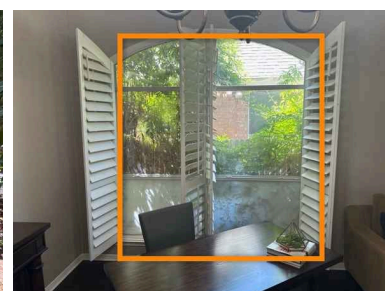
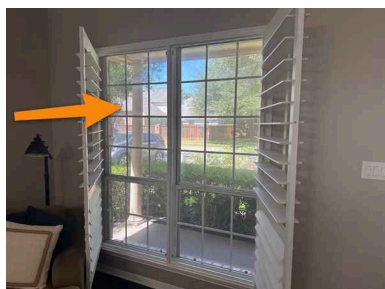
Living Room

Observed one or more windows with condensation and/stain between the window panes, which indicates a failed seal. Recommend qualified window contractor evaluate & replace.

Recommendation: Contact a qualified window repair/installation contractor.

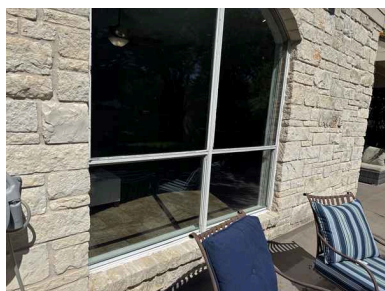
One or more windows are missing a screen. Recommend seller/builder re-hang and /or replace screens where needed before closing.

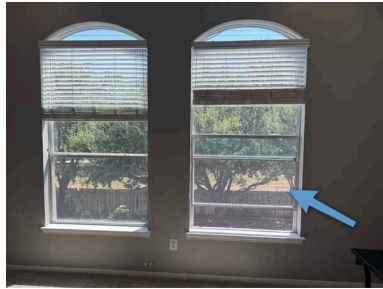
Multiple windows

One or more windows need to be lubricated so they will open more smoothly and prevent balance damage.

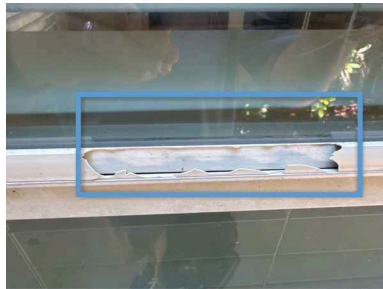
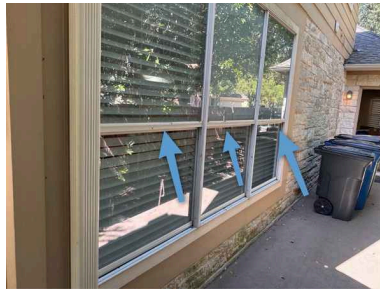
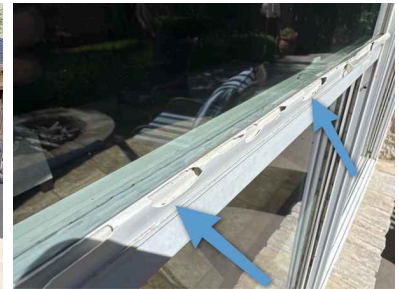
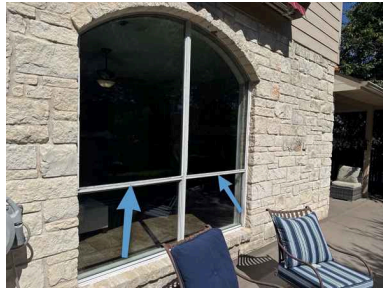
Observe one or more loose and or damaged window gaskets. Recommend repair.

Recommendation: Contact a qualified professional.

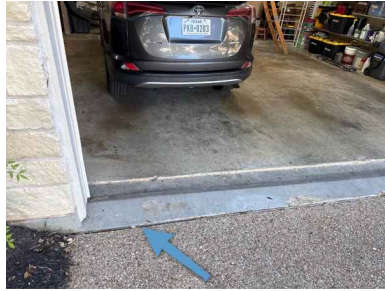
The slab joint between the house and flatwork should be sealed. This separation may allow moisture to wick into the soil near the foundation and could cause expansion of the soil, which may cause settling to occur. Further evaluation and/or repair by a qualified contractor is recommended.

Recommendation: Contact a qualified professional.

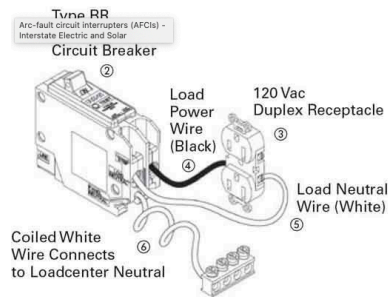
There are no Arc Fault Circuit Interrupt (AFCI) breakers present as called for by recent TREC reporting standards. AFCI breakers are used to protect living area branch circuits that are not GFCI (Ground Fault Circuit Interrupt) protected. When electric service is renovated, it is usually required to bring to service to current code required by local jurisdiction. Further evaluation by licensed electrician may be desired. This technology was not available and/or not required at time home was constructed.

Recommendation: Contact a qualified professional.

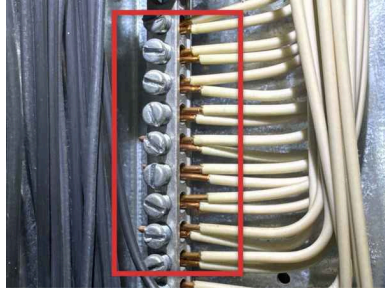
There are double tapped neutral conductors in the electric service panel. Multiple neutral conductors in a single termination create a problem when the circuit needs to be isolated. In order to isolate the circuit, the branch breaker is turned off and the neutral is disconnected by removing it from the terminal. If the terminal is shared with another circuit, the connection on the other (still energized) circuit will be loosened as well. Loosening of the second neutral (loss of neutral) under load is a safety hazard, and may establish an over

voltage condition on lighting and appliances if the neutral is part of a 120/240 Volt AC multi-wire branch circuit. Also, the neutral assemblies are not evaluated with multiple neutral conductors in the same terminal. 2002 NEC Art. 408-21 Grounded Conductor Terminations. Each grounded conductor shall terminate within the panel board in an individual terminal that is not also used for another conductor.

Recommendation: Contact a qualified professional.

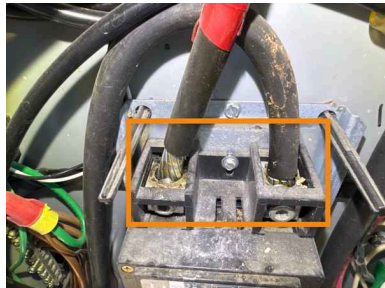
Antioxidant paste missing at main service conductors. Add as needed. This helps protect wires from oxidation and movement.

Recommendation: Contact a qualified professional.

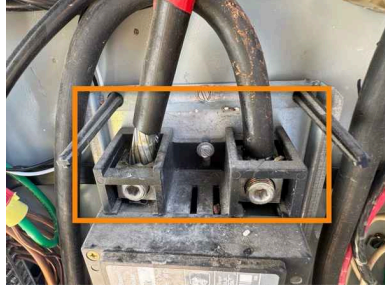
The main service entrance line lugs inside the electrical panel are missing their protective terminal barrier covers. Missing lug covers leave energized main line terminals exposed even when the main disconnect is turned off, presenting a shock hazard to anyone working inside the panel. Recommend having a licensed electrician install approved terminal barrier covers over the main service lugs.

Recommendation: Contact a qualified professional.

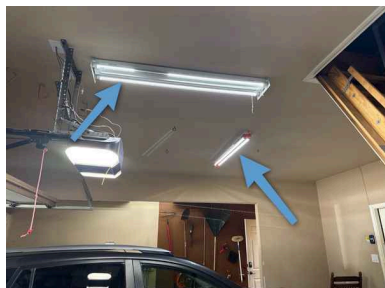
Garage

There are one or more light covers missing or not installed. A cover should be installed to ensure the bulb is properly protected. Bulb cages are normally used in closets and utility applications. light fixture is damaged.

Recommendation: Contact a handyman or DIY project

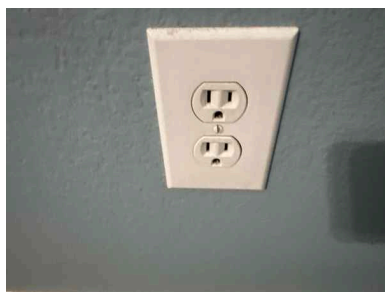
Observed one or more electrical outlets that were not tamper resistant. Current standards (code progression) requires all outlets 5 1/2 feet from the floor to be tamper resistant. This is a child safety issue and may become required to update if renovations include any permit required electrical improvements to meet today's standards.

Recommendation: Contact a qualified professional.

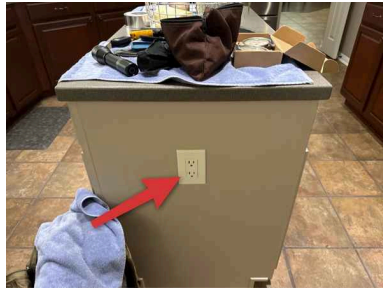
The 2023 National Electrical Code (NEC) prohibits installing outlets on the side of islands as a safety measure to protect children from falling items due to electrical cords.

Recommendation: Contact a qualified professional.

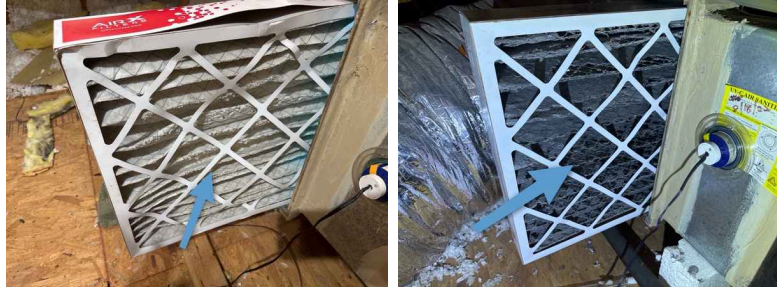
One or more filters were observed to be dirty and should be replaced or cleaned. The fresh air filter should be cleaned every six months. The 4 inch filter at the unit should be replaced every six months and the 1 inch filter at the return air inside the house should be replaced every 30 days.

Recommendation: Contact a handyman or DIY project

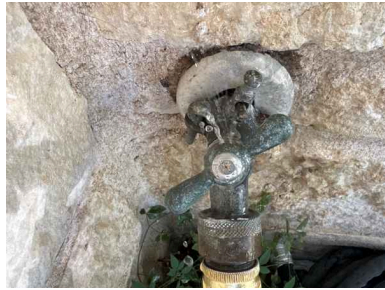
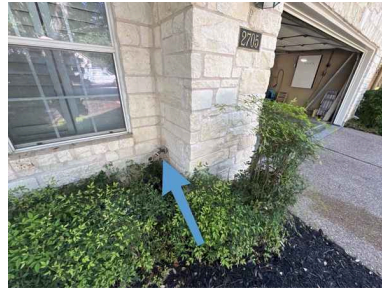
One or more faucet leak at the control handle. Recommend repair

Recommendation: Contact a qualified professional.

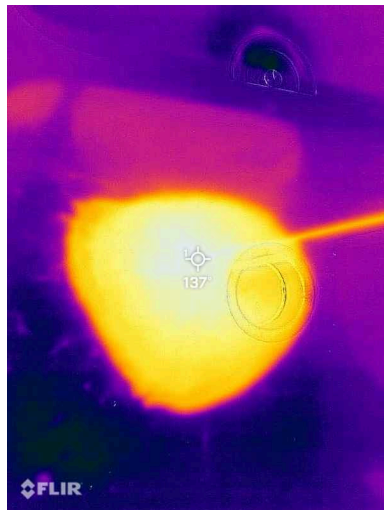
135 degrees

The water temperature is excessive and set too high. Temperatures above 120 could lead to scalding. Recommend setting the water temperature below 120 degrees for safety reasons.

Recommendation: Contact a qualified professional.

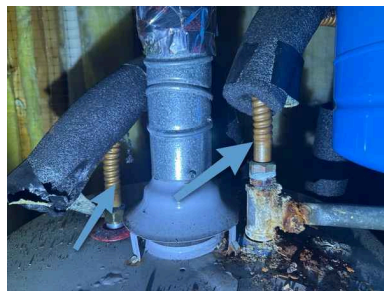
Garage Attic

There is missing insulation at the hot and cold water heater supply pipes. This can result in a loss of thermal gains. Insulation is recommended.

Recommendation: Contact a qualified professional.

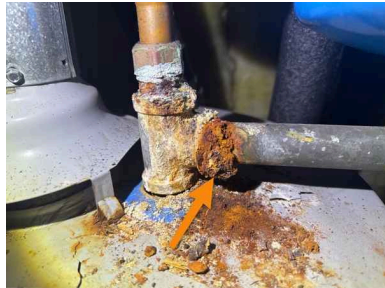
## 3: Corrosion at Pipe Fittings

Corrosion was observed at the water heater pipe fittings. Recommend further evaluation by a licensed plumber.

Recommendation: Contact a qualified professional.

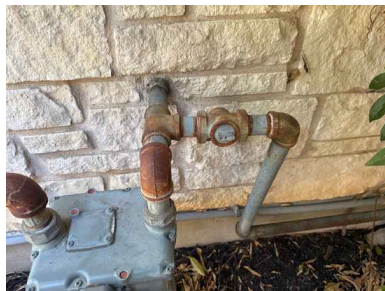
*Gas Meter Bonded at Meter:* No

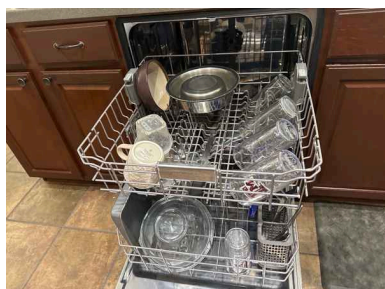
The dishwasher was full of dishes at the time of inspection so not all areas of the dishwasher could be inspected

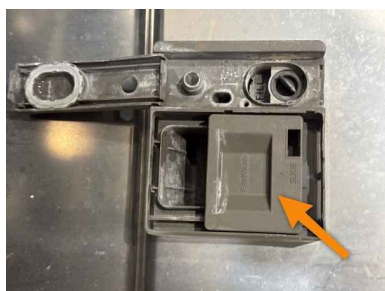
#### 1: Soap Dispenser Inoperable

The soap dispenser door did not close and or open when the unit was tested. Further evaluation and or repair by a qualified contractor is recommended.

Recommendation: Contact a qualified professional.

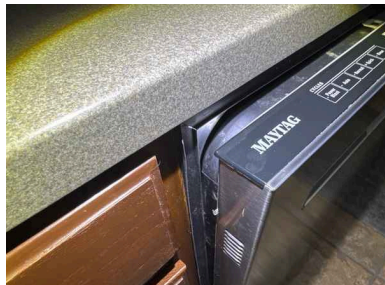
The dishwasher door does not close properly. Recommend repair.

Recommendation: Contact a qualified professional.

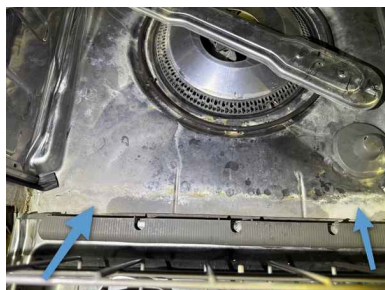
**3: Soap / Calcium Build-Up**

The unit has calcium and or soap buildup . Further evaluation and or Cleaning recommended.

Recommendation: Contact a qualified professional.

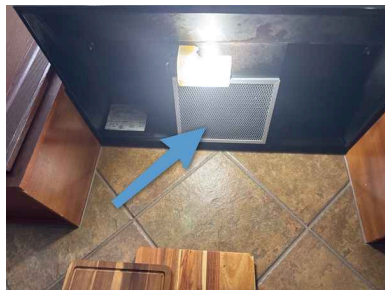
### 1: Noisy

The venthood was noisy at the time of the inspection. The reason could not be determined. Recommend further evaluation by a qualified contractor.

Recommendation: Contact a qualified professional.

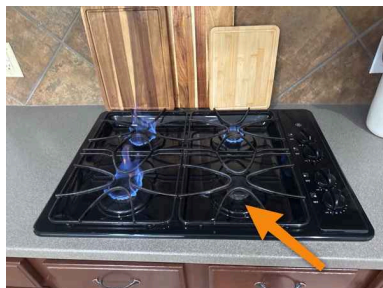
### 1: Burner Not Lighting

Gas burners, not igniting. Recommend qualified professional evaluate & repair.

Recommendation: Contact a qualified handyman.

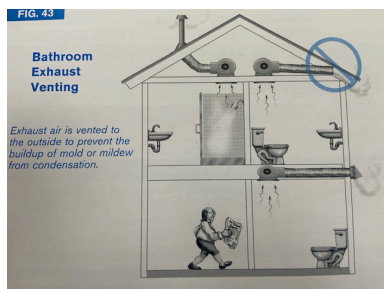
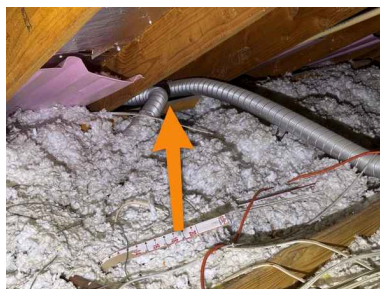
**1: Vents Terminate in Attic****Recommendation**

The exhaust fans terminate into the attic space at soffits. This can allow moisture to accumulate in the attic space and cause damage to insulation and framing member. Recommend further evaluation and repair venting to the exterior of the home through the roof and/or the side wall. This type installation is common for this period of home.

Recommendation: Contact a qualified professional.

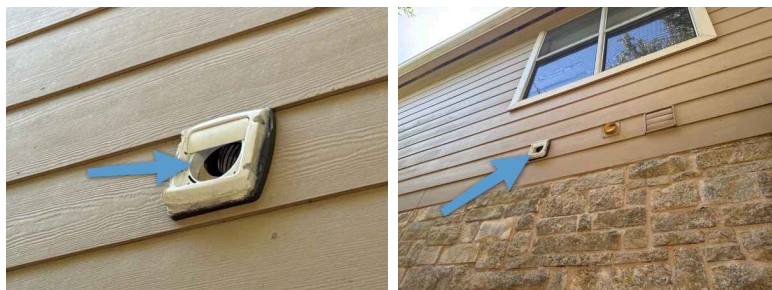
**2: Missing Vent Cover****Maintenance Item**

Observed one or more vent covers that were missing. Recommend installation.

Recommendation: Contact a qualified professional.

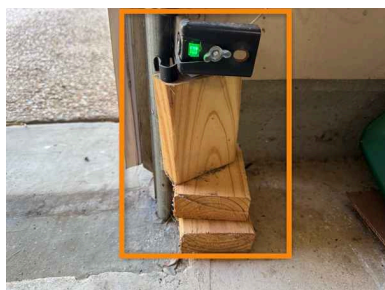
**1: Improperly mounted safety beam**

The garage door photoelectric safety sensors are improperly mounted using unattached wood scraps rather than being securely anchored to the door track or wall framing. This makeshift setup can easily shift out of alignment or fall, potentially disabling the auto-reversing safety mechanism or preventing the door from closing properly. Recommend having a qualified garage door technician properly mount and align the sensors according to manufacturer guidelines.

Recommendation: Contact a qualified professional.

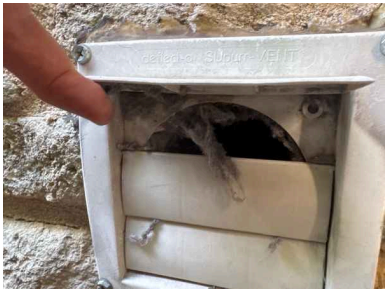
**1: Dryer Vent Lint Excessive**  
 [Maintenance Item](#)

There was a noticeable amount of lint observed in the dryer vent. Cleaning the vent is recommended. This should also allow flap to close when not in use.

Recommendation: Recommended DIY Project

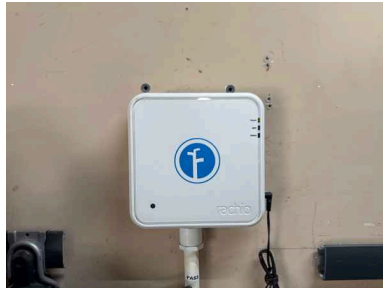
The irrigation system could not be tested. The control panel requires an application and a wifi signal.  
Contact seller to test the system
