PRO-CERTIFIED HOME INSPECTION, PLLC

## RESIDENTIAL INSPECTION

4204 Sevilla Dr  
Georgetown, TX 78628

# PROPERTY INSPECTION REPORT FORM

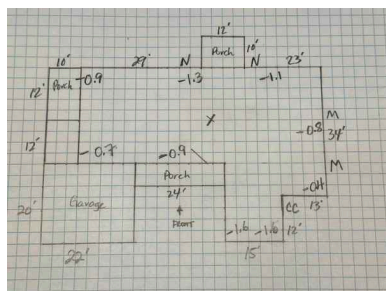
The foundation shows signs of heaving or settling that exceed normal tolerances. This condition was observed during the structural inspection and indicates movement in the foundation system. Foundation movement can lead to structural stress, cracking, and potential damage to the home's integrity. A structural engineer should evaluate the extent of movement, identify the cause, and recommend appropriate corrective measures or monitoring.

Recommendation: Contact a qualified structural engineer.

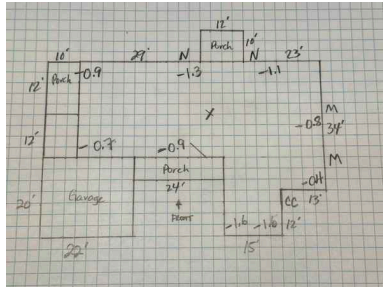
## 2: Tree Near Foundation

The tree near the house foundation can cause foundation movement due to the roots extracting water from the soil causing a drying or shrinking effect. You may wish to consult with a service company about installation of root barriers which may prevent feeder roots from nearby trees from migrating below the structure and extracting moisture from under the slab foundation. Root barriers are usually placed as far from the tree and as near to the foundation as possible in order to decrease damage to the tree roots.

Recommendation: Contact a qualified professional.

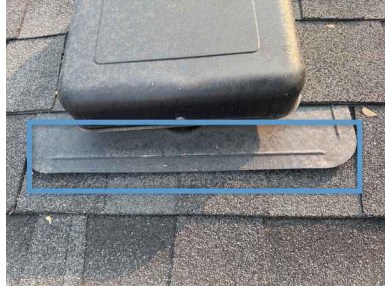
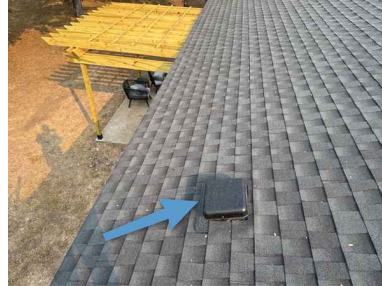
**3: Missing Flashing Fasteners**

Observed one or more areas that were missing the fastener at the flashing. Recommend repair by nailing, flashing and sealing the nail head to prevent leaks.

Recommendation: Contact a qualified professional.

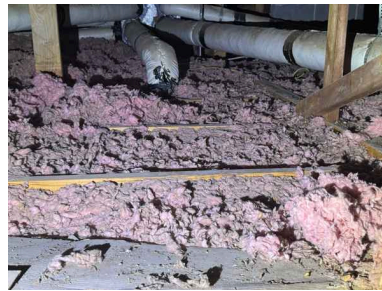
## 2: Debris in Attic

There is construction debris and/or personal property in the attic area. Remove recommended.

Recommendation: Contact a qualified professional.

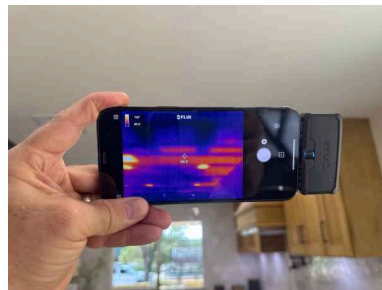
Kitchen

Insulation was observed to be insufficient or missing in one or more areas of the home with thermal imaging. Recommend insulation in these areas to better improve energy efficiency.

Recommendation: Contact a qualified professional.

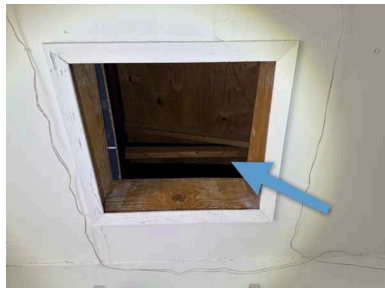
### 4: Missing Scuttle Cover

This scuttle cover is missing in the garage. This is a safety hazard due to the possibility of a fire in the garage could spread to the attic space. Recommend installation of scuttle cover.

Recommendation: Contact a qualified professional.

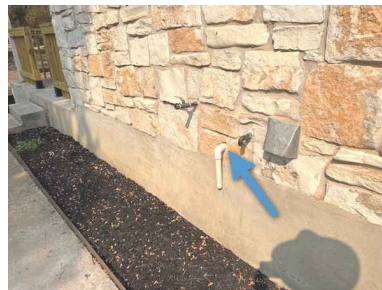
### 1: Seal Wall Penetrations

There were one or more areas where a penetration of the wall was not sealed correctly. Recommend sealing the areas to prevent water intrusion and the possibly of rodents and pests getting into the wall cavity and attic area. Photos are a sampling of wall penetrations.

Recommendation: Contact a handyman or DIY project

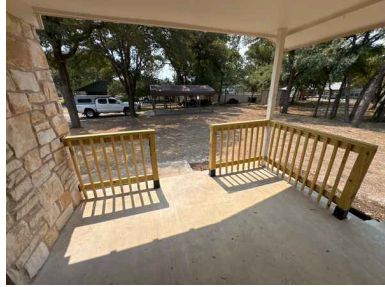
### 3: Unpainted Patio Structure

The wooden patio framing structure is unpainted and unstained, leaving the raw lumber fully exposed to the elements. Unprotected exterior wood is susceptible to moisture damage, weathering, checking, and premature wood rot or decay over time. Have a qualified professional clean and apply a protective paint or exterior-grade sealant/stain to preserve the structural integrity and lifespan of the wood.

Recommendation: Contact a qualified professional.

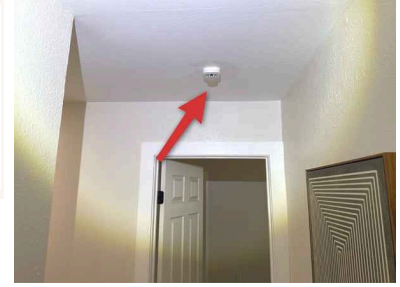
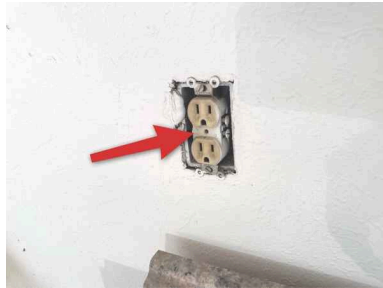
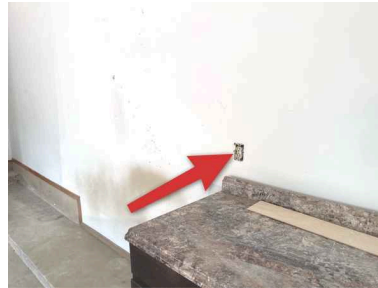
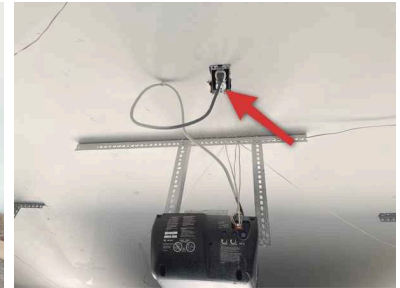
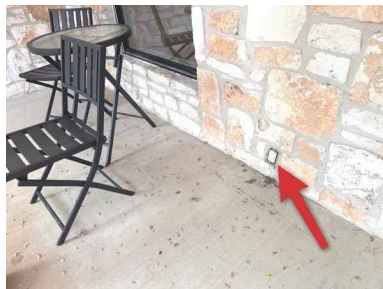
## 2: Cover Plates Missing

One or more receptacles, junction boxes and or light switches are missing a cover plate. This causes short and shock risk. Recommend installation of plates.

Recommendation: Contact a qualified electrical contractor.

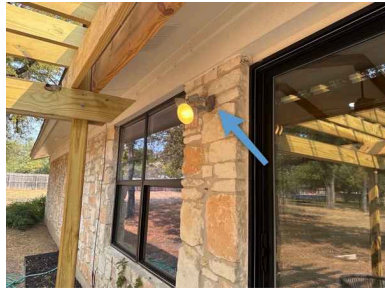
#### 4: Light Cover Missing / Damaged

There are one or more light covers missing or not installed. A cover should be installed to ensure the bulb is properly protected. Bulb cages are normally used in closets and utility applications. light fixture is damaged.

Recommendation: Contact a handyman or DIY project

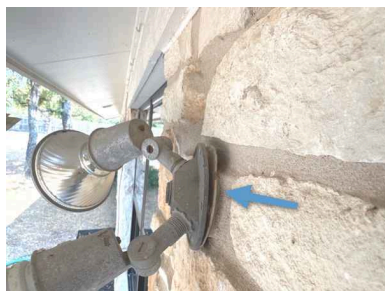
#### 6: Light Bulb Missing

One or more light bulbs were missing at the time of the inspection. Recommend replacement.

Recommendation: Recommended DIY Project

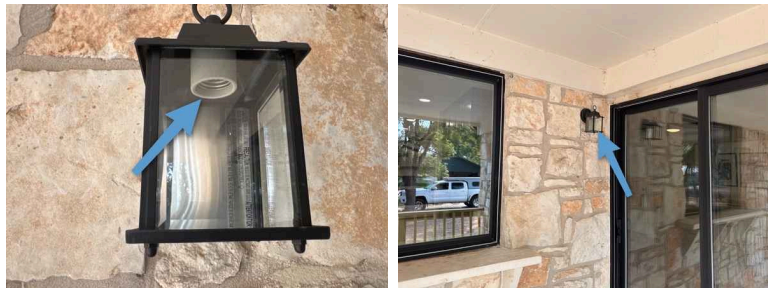
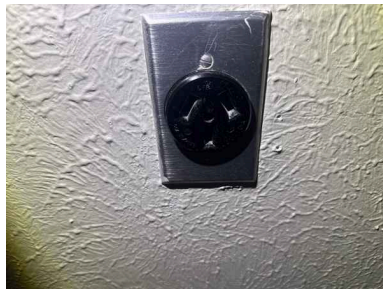
Laundry room

## 7: Three Prong Dryer Outlet

A 3-prong dryer outlet was observed in this home. In 1996, the National Electrical Code was changed to require a new homes to have 4 prong outlets for electrical clothes dryers. This helped remove the potential for electrical shock. Most new dryers will utilizes a 4 prong outlet. Recommend further evaluation and correction by qualified electrician.

Recommendation: Contact a qualified professional.

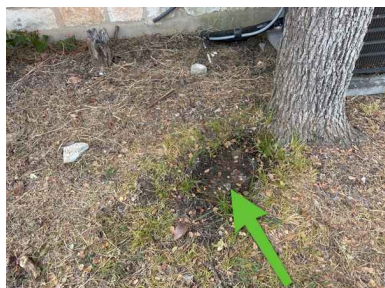
**1: Primary Obstructed****Recommendation**

The primary condensate drain line is obstructed/ buried in a way that may not allow proper drainage. Recommend further evaluation by a qualified contractor.

Recommendation: Contact a qualified professional.

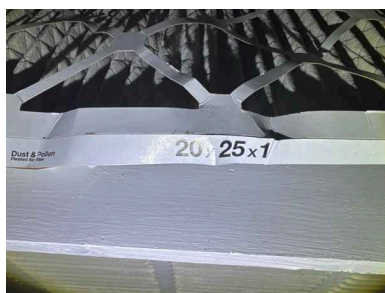
**1: Dirty Filter**

One or more filters were observed to be dirty and should be replaced or cleaned. The fresh air filter should be cleaned every six months. The 4 inch filter at the unit should be replaced every six months and the 1 inch filter at the return air inside the house should be replaced every 30 days.

Recommendation: Contact a handyman or DIY project

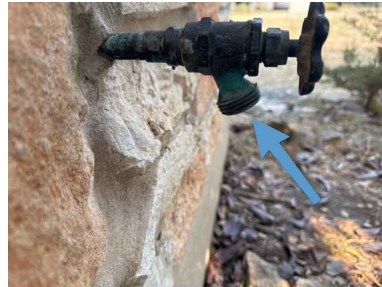
**1: Missing Anti-Siphon @ Hose Bibs**

One or more exterior faucets are missing anti siphon devices. Recommend installing as necessary to prevent possible back flow into water supply.

Recommendation: Contact a handyman or DIY project

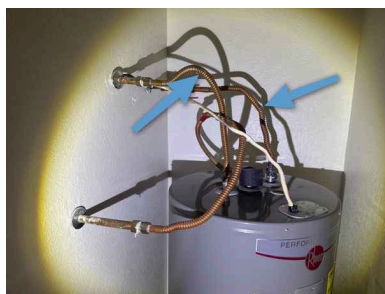
There is missing insulation at the hot and cold water heater supply pipes. This can result in a loss of thermal gains. Insulation is recommended.

Recommendation: Contact a qualified professional.

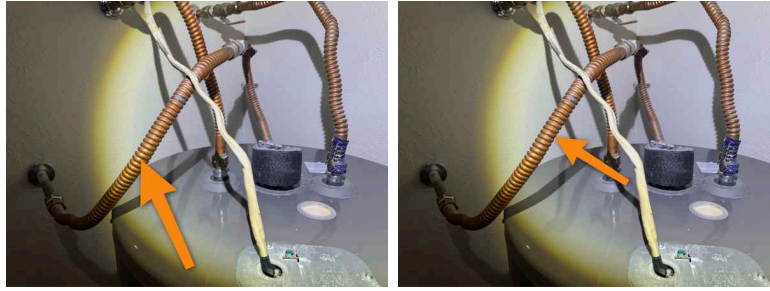
**2: TPR IMPROPER DISCHARGE MATERIAL**

The temperature and pressure relief (TPR) valve discharge pipe is constructed of flexible corrugated copper tubing rather than approved smooth-wall piping. Corrugated tubing restricts flow during a discharge event, which increases the risk of excessive pressure buildup in the tank and can cause valve failure. A qualified licensed plumber should evaluate and replace the flexible line with an approved, rigid discharge pipe extending to a safe point of disposal.

Recommendation: Contact a qualified professional.

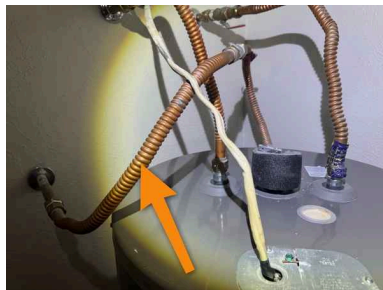
### 3: TPR DISCHARGE IMPROPER SLOPE

The TPR valve discharge pipe routes upward above the valve body, creating an unpitched trap that retains water. Trapped water causes mineral accumulation and corrosion that can seize the relief valve or restrict flow during a thermal expansion event. A qualified licensed plumber should re-route the discharge line to maintain a continuous slope downward to an approved termination point.

Recommendation: Contact a qualified professional.

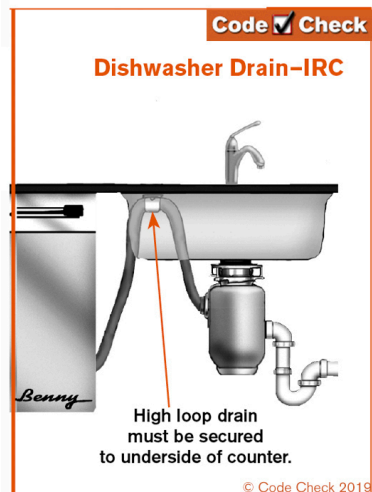
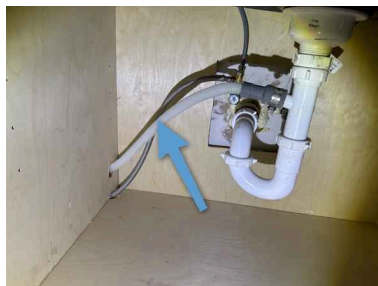
### 1: Improper Backflow Prevention

The dishwasher drain is not properly installed which can cause sink water to flow into the dishwasher. Recommend proper installation. Refer to high loop diagram below.

Recommendation: Contact a handyman or DIY project

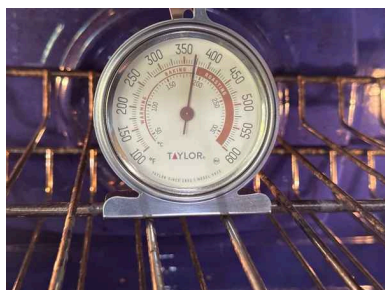
Lower oven

One or more ovens did not heat to 350 degrees. Recommend having oven calibrated by an appliance repair technician to obtain the desired temperature.

Recommendation: Contact a qualified professional.

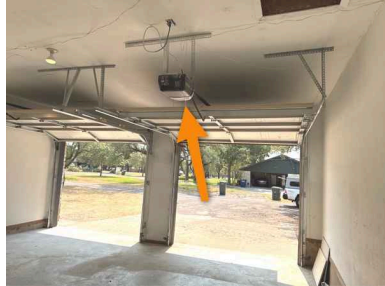
**1: Not Operating Properly**

The garage door opener was not operating properly at the time of the inspection. Recommend further evaluation by a qualified contractor.

Recommendation: Contact a qualified professional.

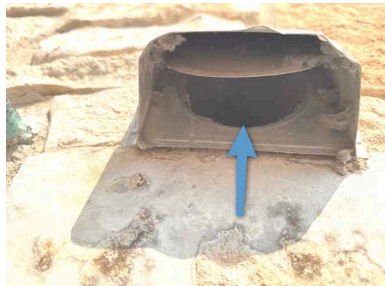
The dryer vent damper is stuck open due to excessive lint, and/or misaligned or bent damper. Recommend cleaning the dryer duct.

Recommendation: Contact a qualified professional.
