PRO-CERTIFIED HOME INSPECTION, PLLC

## RESIDENTIAL INSPECTION

216 Flying Tigers Trl  
Jarrell, TX 76537

# PROPERTY INSPECTION REPORT FORM

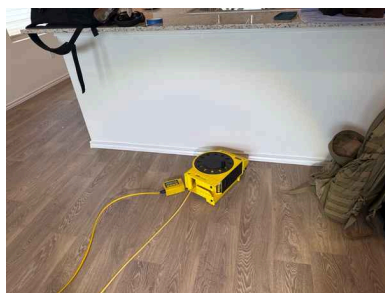
Zero reference point, living room

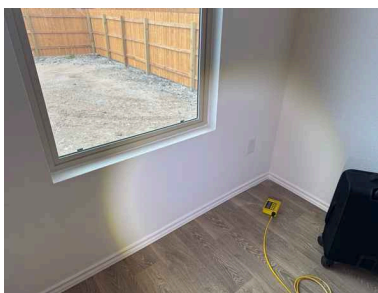
Zero, Living Room

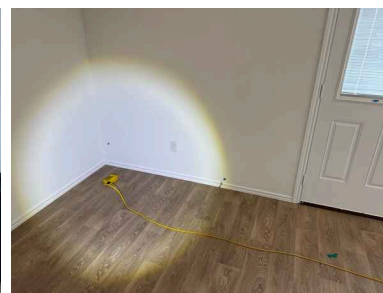
-0.3, Living Room

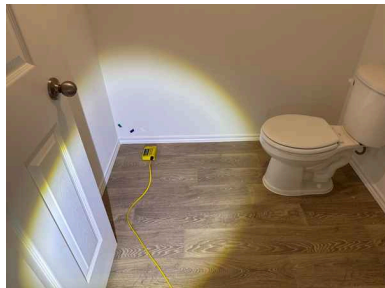
0.1, Bathroom

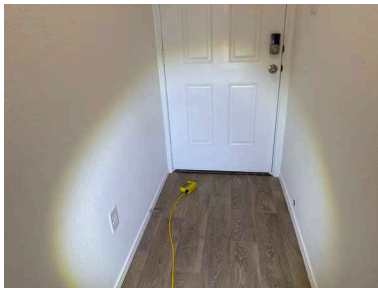
-0.3, foyer

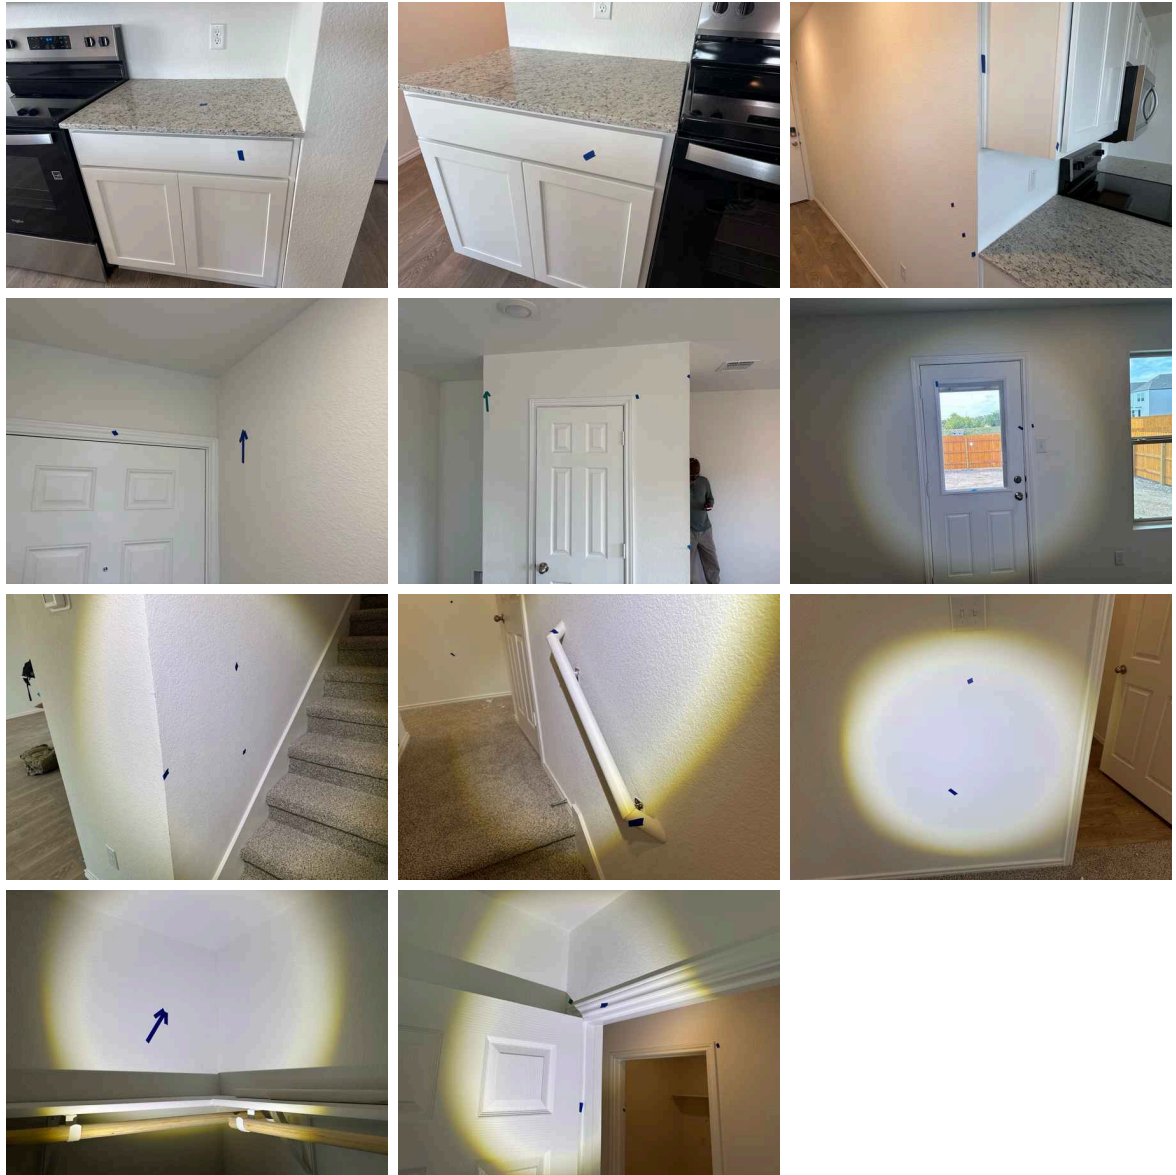
**Blue Taped Walls:**

There are numerous walls with blue tape. These are typically minor imperfections such as texture and consistency paint touchup caulking. These photos are for reference.

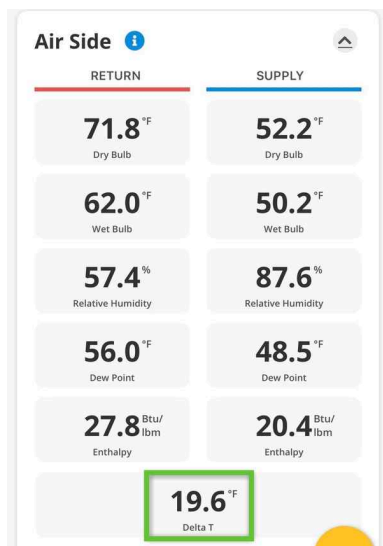
The desired temperature differential is between 15 and 22°. Refer to comments below:

The temperature differential was 19.6° at the time of inspection.
